# Inspection Report

## Custom Built New Home Listed at over \$500,000

**Property Address:**  
123 New Home Way  
Any City, SC

**King Construction, Inc dba Inspector Paul**

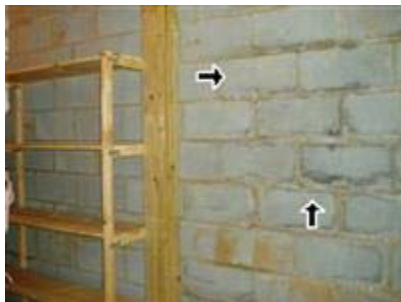
1.0 Picture 1

1.0 (1) Visible signs of water intrusion in basement (along front of home) and (left side of home facing front) are present from silt stains and water stains on along the block walls. Discoloration of the blocks under the front door, along the front and left side walls are indications of abnormal water penetration. We could not locate any foundation drainage pipes. Recommend further investigation by a licensed contractor, professional engineer, or water infiltration specialist.

(1) Visible signs of water intrusion in basement (along front of home) and (left side of home facing front) are present from silt stains and water stains on along the block walls. Discoloration of the blocks under the front door, along the front and left side walls are indications of abnormal water penetration. We could not locate any foundation drainage pipes. Recommend further investigation by a licensed contractor, professional engineer, or water infiltration specialist.

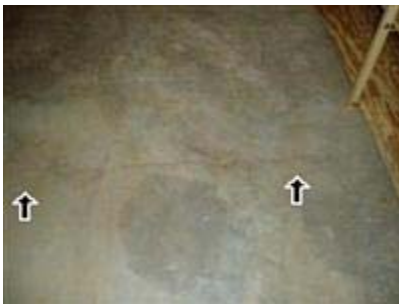
1.0 Picture 8

(2) A long crack was inspected in the basement slab, starting at the left side wall near the water main and heading towards the basement bathroom area. A crack was inspected in the front left corner of the basement, under the entrance foyer area. Cracks were located in the basement slab around the wood support posts for the LVL girders, we could not determine if the slab was properly poured to support the additional load under the vertical posts. Evidence suggests that these conditions are also present in the inaccessible / finished areas of the basement but that can no be confirmed with out being destructive. A structural engineer should be retained to determine if the condition exists at all foundation areas where columns are installed and repairs should be made per their recommendations.

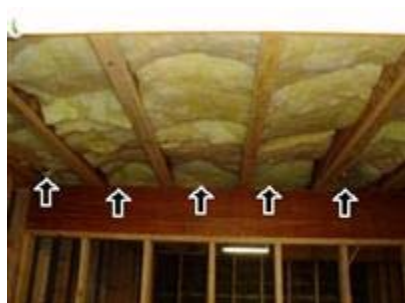
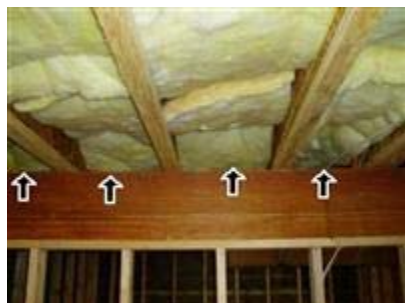
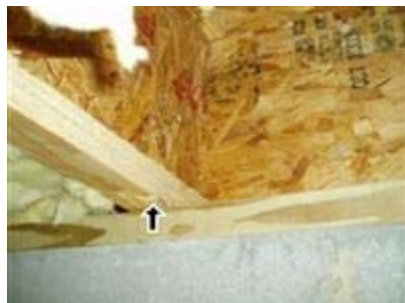
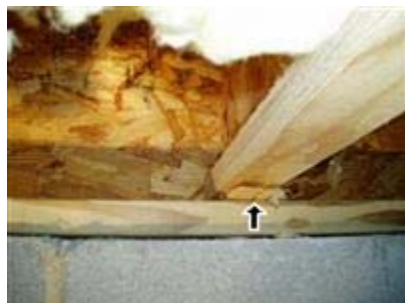
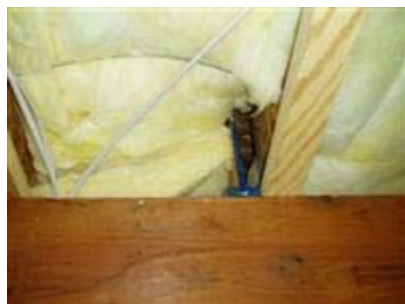
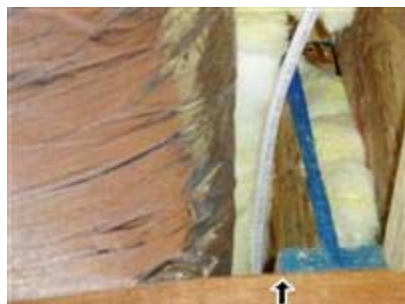
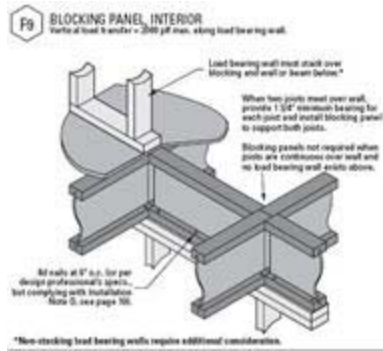
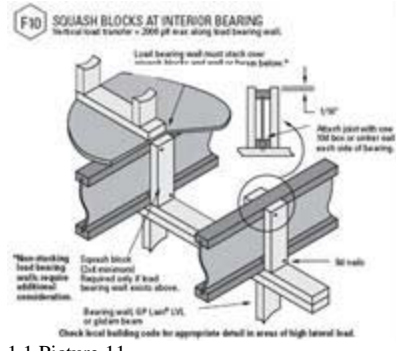
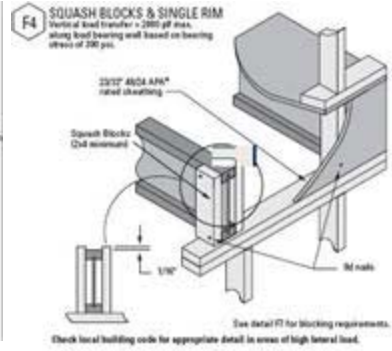
**1.1** All visible areas of floors are missing blocking panels, web stiffeners, and squash blocks that should be installed in accordance with manufacturers instructions. Several engineered I joists have wood wedge shims installed between the mudsill and bottom of the joist. The rim band on the front of the home and rear of the home are engineered I joists, these may not be structurally sound to support the loads above. Repairs are advised for structural integrity. The floor joists manufacturer instructions are attached to the end of this report for clarification. Evidence suggests that these conditions are also present in the inaccessible / finished areas of the basement but that can no be confirmed with out being destructive. A structural engineer should be retained to determine if the condition exists at all floor areas and repairs should be made per their recommendations.

All visible areas of floors are missing blocking panels, web stiffeners, and squash blocks that should be installed in accordance with manufacturers instructions. Several engineered I joists have wood wedge shims installed between

the mudsill and bottom of the joist. The rim band on the front of the home and rear of the home are engineered I joists, these may not be structurally sound to support the loads above. Repairs are advised for structural integrity. The floor joists manufacturer instructions are attached to the end of this report for clarification. Evidence suggests that these conditions are also present in the inaccessible / finished areas of the basement but that can no be confirmed with out being destructive. A structural engineer should be retained to determine if the condition exists at all floor areas and repairs should be made per their recommendations.

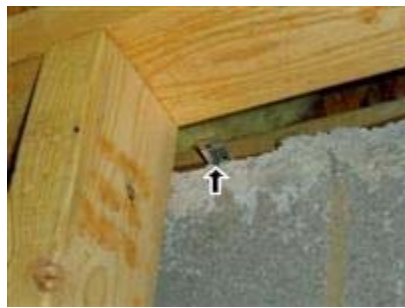
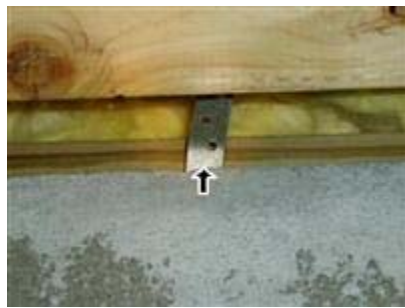
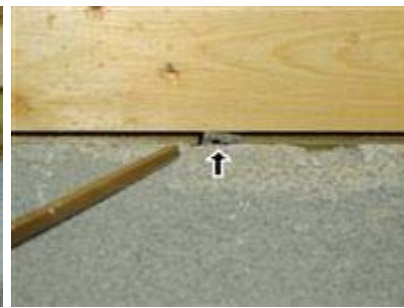
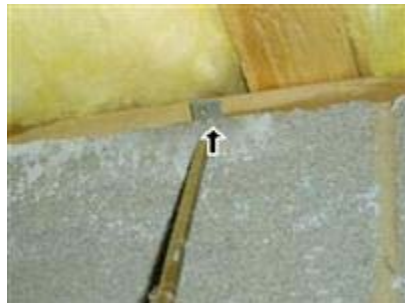
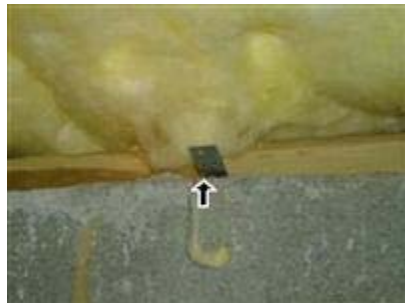
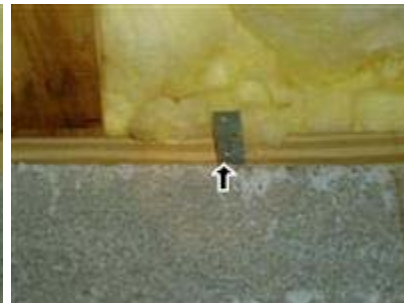
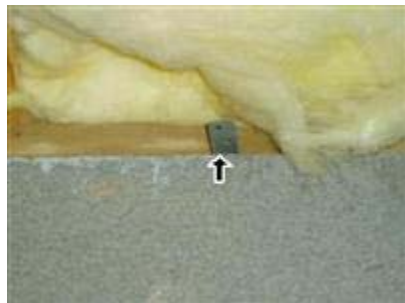
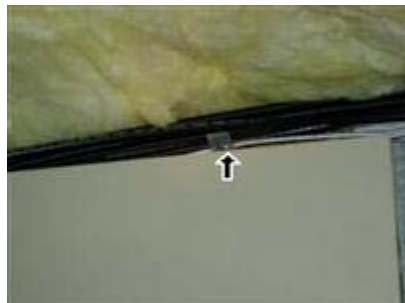
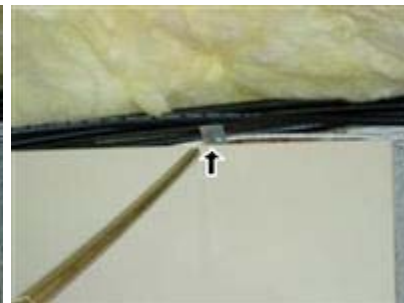
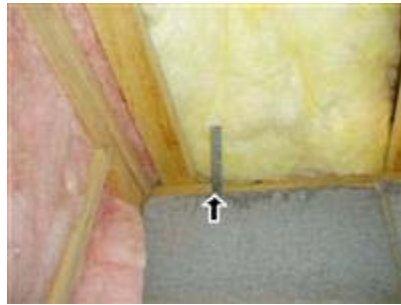
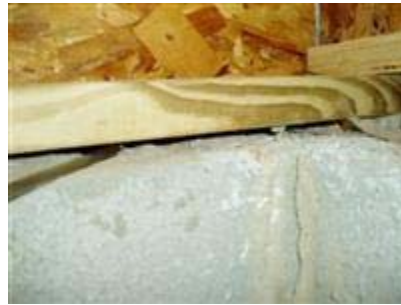
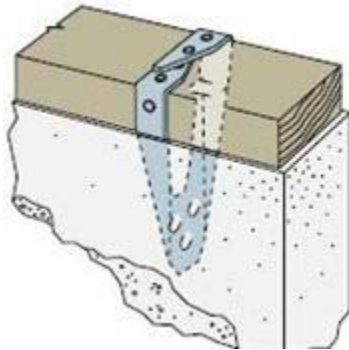
1.2 (1) The mudsill should be secured to the block foundation wall with proper anchor bolts or mudsill anchors per manufacturers instructions. We could not locate a single anchor bolt and every mudsill anchor we could locate did not have a single nail securing the mudsill to the block wall. Manufacturers installation instructions are attached to the report. Evidence suggests that this condition is also present in the inaccessible/finished areas of the basement but that can no be confirmed with out being destructive. A structural engineer should be retained to determine if the condition exists at all walls and repairs should be made per their recommendations.

(1) The mudsill should be secured to the block foundation wall with proper anchor bolts or mudsill anchors per manufacturers instructions. We could not locate a single anchor bolt and every mudsill anchor we could locate did not have a single nail securing the mudsill to the block wall. Manufacturers installation instructions are attached to the report. Evidence suggests that this condition is also present in the inaccessible/finished areas of the basement but that can no be confirmed with out being destructive. A structural engineer should be retained to determine if the condition exists at all walls and repairs should be made per their recommendations.

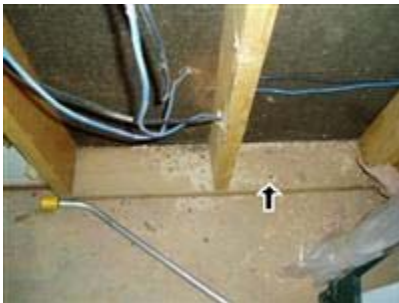
1.2 Picture 14

(2) The only visible section of rear foundation wall, to the concrete slab, is being secured in place by a single nail, no anchor bolt(s) or mudsill anchor(s) could be located. Evidence suggests that this condition is also present in the finished areas of the basement but that can no be confirmed with out being destructive. A structural engineer should be retained to determine if the condition exists at all walls and repairs should be made per their recommendations.

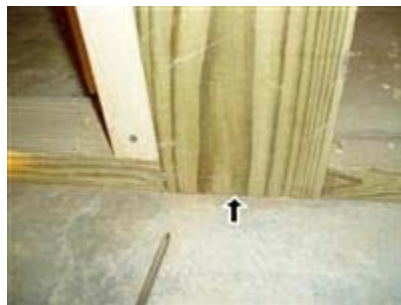
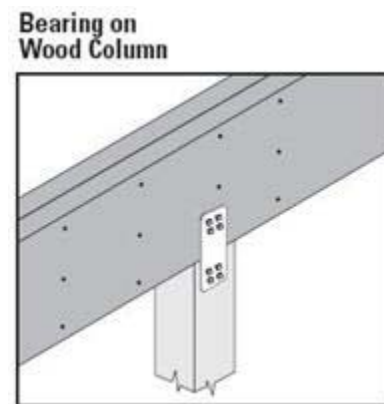
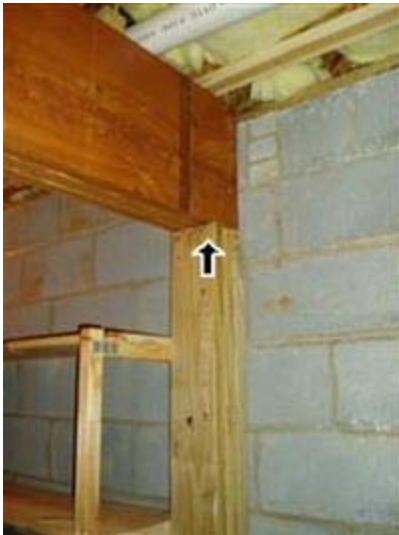
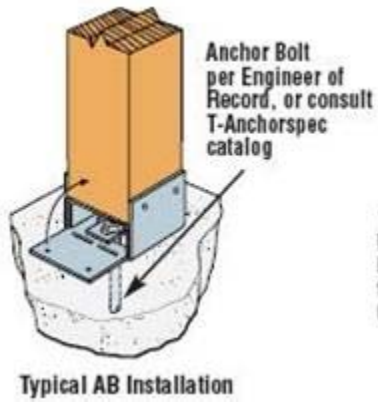
1.3 All visible vertical support posts are not secured to the foundation, and against racking forces. The LVL beams are not secured to the vertical posts in accordance with manufacturers instructions. Manufacturers installation instructions are attached to the report. Evidence suggests that this condition is also present in the inaccessible / finished areas of the basement but that can no be confirmed with out being destructive. A structural engineer should be retained to determine if the condition exists at all columns and repairs should be made per their recommendations.

All visible vertical support posts are not secured to the foundation, and against racking forces. The LVL beams are not secured to the vertical posts in accordance with manufacturers instructions. Manufacturers installation instructions are attached to the report. Evidence suggests that this condition is also present in the inaccessible / finished areas of the basement but that can no be confirmed with out being destructive. A structural engineer should be retained to determine if the condition exists at all columns and repairs should be made per their recommendations.

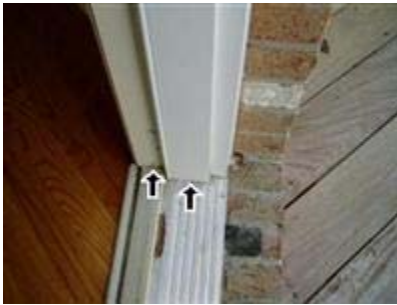
2.1 Picture 1

2.1 (1) Corner seal pads should be installed and caulking applied at all exterior doors jambs where they meet the steel threshold per manufacturers recommendations and to prevent water intrusion and deterioration. Recommend further evaluation and repair as needed by a qualified licensed general contractor.

(1) Corner seal pads should be installed and caulking applied at all exterior doors jambs where they meet the steel threshold per manufacturers recommendations and to prevent water intrusion and deterioration. Recommend further evaluation and repair as needed by a qualified licensed general contractor.

**9 Check or install corner seal pads.  
(Swing-in doors only)**

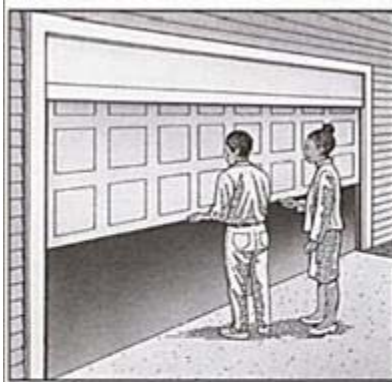
2.3 Picture 1

2.3 The two garage doors closest to the home do not have opener buttons installed in the garage and could not be tested for proper and safe operation. Garage Door, at the single car section, does not reverse when met with resistance (safety hazard). Recommend further evaluation and adjustment or repair as needed by a licensed general contractor.

The two garage doors closest to the home do not have opener buttons installed in the garage and could not be tested for proper and safe operation. Garage Door, at the single car section, does not reverse when met with resistance (safety hazard). Recommend further evaluation and adjustment or repair as needed by a licensed general contractor.

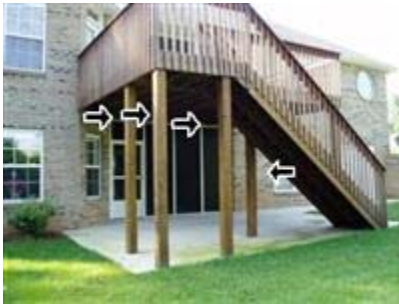
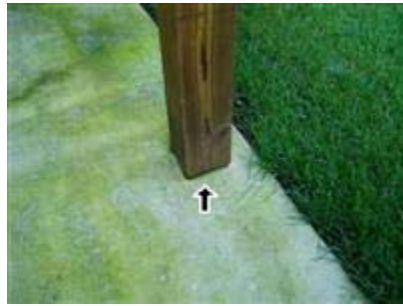
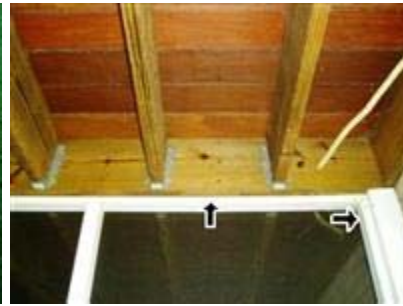
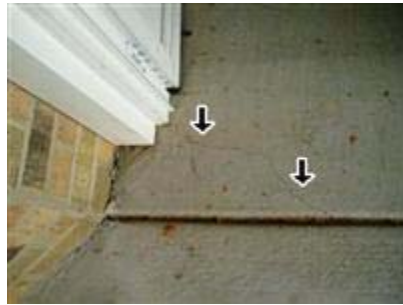
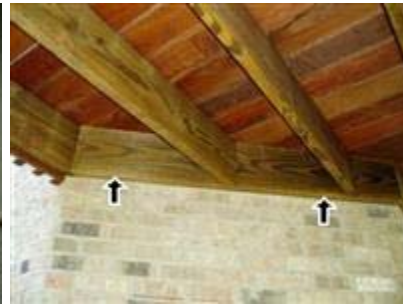
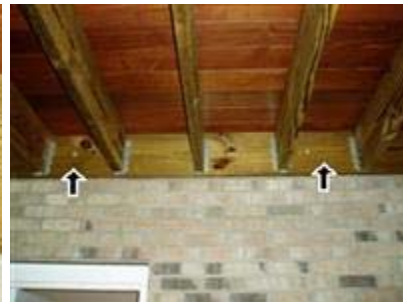
2.4 (1) Vertical deck posts on the rear of the home are installed on top of the concrete patio instead of being installed in a proper footing and each post should have a 4 by 4 knee brace in each direction to support the deck against racking forces. Inspected a doubled 2 by girder at the mid point of the deck; evidence suggests that the girder is being supported by 2 by 4 stud(s) (behind the white metal wrapping) and that the 2 by 4 studs may be resting on the concrete patio (the patio has cracked at the left corner post and around the three exterior posts). The deck band at the bay area of the den is only attached

to the brick veneer with nails and no joist hangers are supporting the joists at the same location. All of the lag bolts where the deck band connects to the brick veneer are missing washers and bolts. Visible sections of the rim band on the rear of the home are prefabricated I joists, we could not determine if the proper deck attachment was installed. Recommend a structural engineer evaluate further and repairs be made per their recommendations.

forces. Inspected a doubled 2 by girder at the mid point of the deck; evidence suggests that the girder is being supported by 2 by 4 stud(s) (behind the white metal wrapping) and that the 2 by 4 studs may be resting on the concrete patio (the patio has cracked at the left corner post and around the three exterior posts). The deck band at the bay area of the den is only attached to the brick veneer with nails and no joist hangers are supporting the joists at the same location. All of the lag bolts where the deck band connects to the brick veneer are missing washers and bolts. Visible sections of the rim band on the rear of the home are prefabricated I joists, we could not determine if the proper deck attachment was installed. Recommend a structural engineer evaluate further and repairs be made per their recommendations.

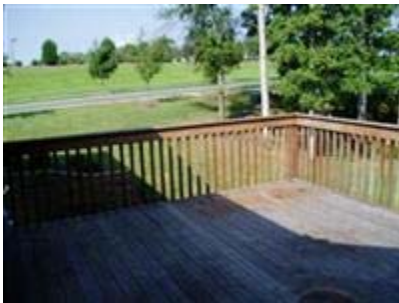
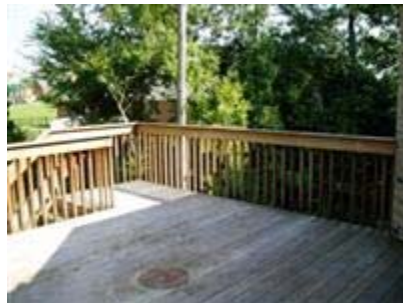
(2) Handrails and guardrails at the deck on the rear of the home and stairs to the deck are secured by 2" pickets only; reinforcement are needed for safety. Recommend further evaluation and repair as needed by a qualified licensed general contractor.

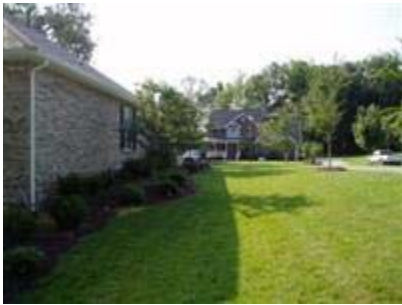
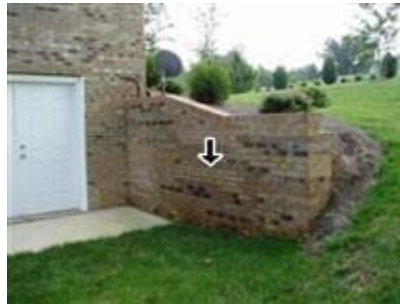
2.5 Negative slope towards left side (facing front). This area does not drain water away from home and needs landscaping and drainage corrected. No allowance for drainage was installed at the brick retaining wall in the left rear corner of the home. The bricks at retaining wall at the left rear corner of the home are darker near the base indicating there may be excessive water on the other side of the wall. We could not determine if a foundation drain was installed because we could not locate a termination point. Recommend further evaluation and repair as needed by a qualified licensed general contractor.

Negative slope towards left side (facing front). This area does not drain water away from home and needs landscaping and drainage corrected. No allowance for drainage was installed at the brick retaining wall in the left rear corner of the home. The bricks at retaining wall at the left rear corner of the home are darker near the base indicating there may be excessive water on the other side of the wall. We could not determine if a foundation drain was installed because we could not locate a termination point. Recommend further evaluation and repair as needed by a qualified licensed general contractor.

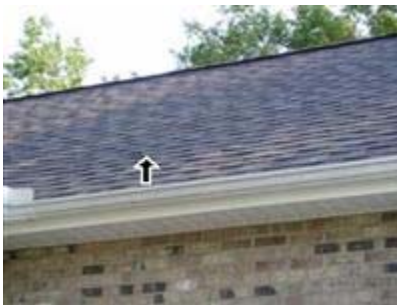
3.0 Picture 1

3.0 Minor damage was observed at the roof shingles over the garage closest to the home. Recommend further evaluation and repair as needed by a qualified licensed general contractor.

Minor damage was observed at the roof shingles over the garage closest to the home. Recommend further evaluation and repair as needed by a qualified licensed general contractor.

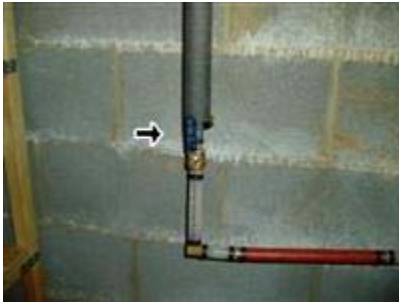
4.3 Picture 1

**4.3** The main shut-off is the blue lever located on the left wall in the basement (For your info).

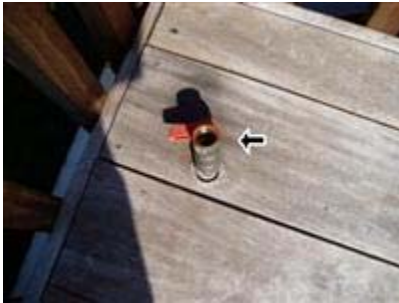
4.4 Picture 1

**4.4** Gas line is missing a cap and can be turned on inadvertently on the deck outside. Recommend repair as necessary by a qualified professional.

Gas line is missing a cap and can be turned on inadvertently on the deck outside. Recommend repair as necessary by a qualified professional.

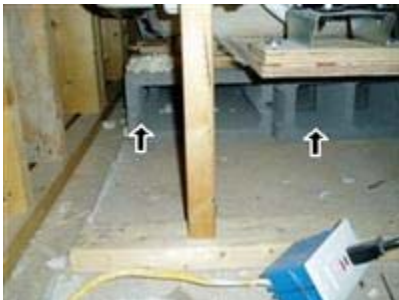
4.6 Picture 1

**4.6** Jetted tub is installed on vertically oriented CMU blocks. The blocks provide minimal structural support in this orientation. Filling the tub with water and a person may cause the blocks to break. Recommend further evaluation and repair as needed by a qualified licensed general contractor.

Jetted tub is installed on vertically oriented CMU blocks. The blocks provide minimal structural support in this orientation. Filling the tub with water and a person may cause the blocks to break. Recommend further evaluation and repair as needed by a qualified licensed general contractor.

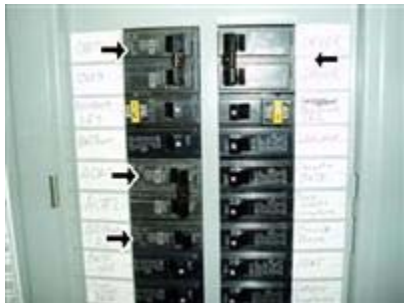
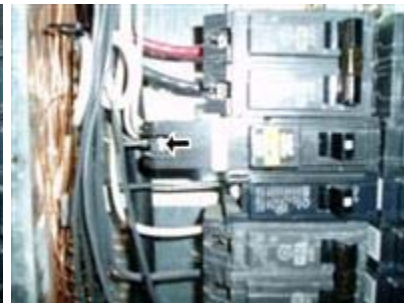
**5.2 (1)** Several circuit breakers in main panel are of a different brand than panel manufacturer. The manufacturer requires that in order for the panel to be safe, only their brand is allowed to be used inside the panel. Even though these circuit breakers are all "UL approved," they are not approved to be used in panels of different manufacturers unless so indicated on the panel label. Problem(s) discovered with Branch Circuits such as Doubled wiring at circuit(s), Improper size/gauge wiring, and any other problems that an electrician may discover while performing repairs need correcting. Recommend a licensed electrician inspect further and correct as needed.

(1) Several circuit breakers in main panel are of a different brand than panel manufacturer. The manufacturer requires that in order for the panel to be safe, only their brand is allowed to be used inside the panel. Even though these circuit breakers are all "UL approved," they are not approved to be used in panels of different manufacturers unless so indicated on the panel label. Problem(s) discovered with Branch Circuits such as Doubled wiring at circuit(s), Improper size/gauge wiring, and any other problems that an electrician may discover while performing repairs need correcting. Recommend a licensed electrician inspect further and correct as needed.

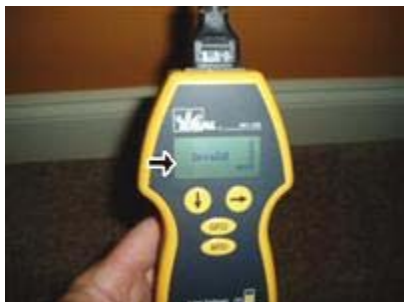
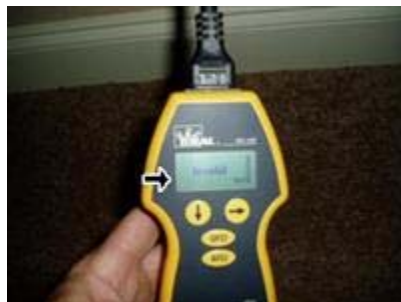
**(2)** The ARC Fault Circuits were tested for proper operation using an Ideal Suretest 61-155 circuit tester. The circuit for both basement bedrooms failed to trip when tested, indicating that ARC fault circuits are not installed for the basement bedrooms or the ARC fault circuits for the basement bedrooms are not functioning as intended. Recommend repair or replacement as needed by a licensed electrician for safety.

(2) The ARC Fault Circuits were tested for proper operation using an Ideal Suretest 61-155 circuit tester. The circuit for both basement bedrooms failed to trip when tested, indicating that ARC fault circuits are not installed for the basement bedrooms or the ARC fault circuits for the basement bedrooms are not functioning as intended. Recommend repair or replacement as needed by a licensed electrician for safety.

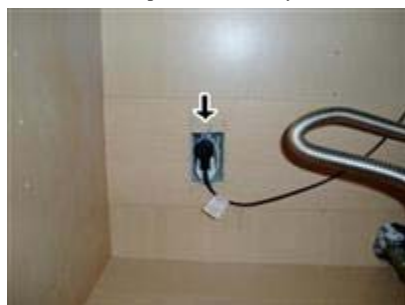
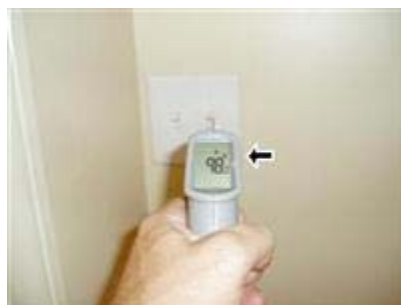
5.3 Outlet in the cabinet under the cooktop is missing a coverplate (safety hazard). Dimmer light switch in the living room area, just outside of the master bedroom door is overheated (98 degrees), electrical hazard. Outlets in the basement are missing coverplates (safety hazard). Recommend further evaluation and repair as needed by a licensed electrical contractor.

Outlet in the cabinet under the cooktop is missing a coverplate (safety hazard). Dimmer light switch in the living room area, just outside of the master bedroom door is overheated (98 degrees), electrical hazard. Outlets in the basement are missing coverplates (safety hazard). Recommend further evaluation and repair as needed by a licensed electrical contractor.

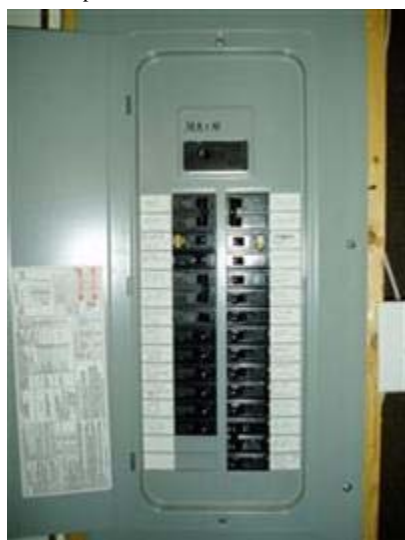
5.7 Picture 1

5.7 Main panel box is located at basement.

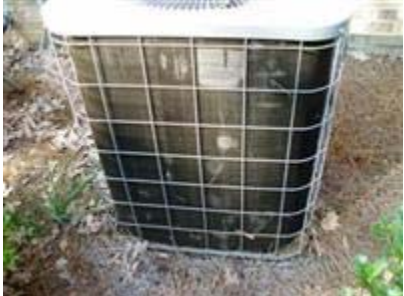
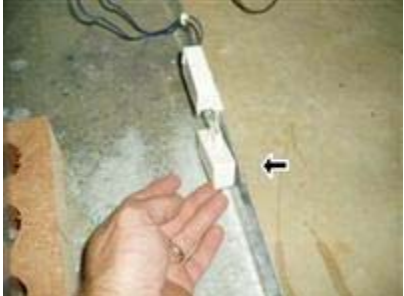
7.0 (1) Cooling fins on compressor are bent and damaged. Recommend service or repair unit using a licensed HVAC contractor. Activating the float switch at both drain pans does not turn off the unit. Recommend further evaluation and repair as needed by a licensed HVAC contractor.

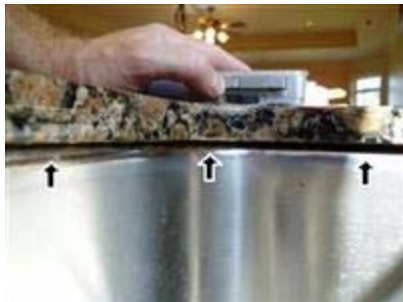
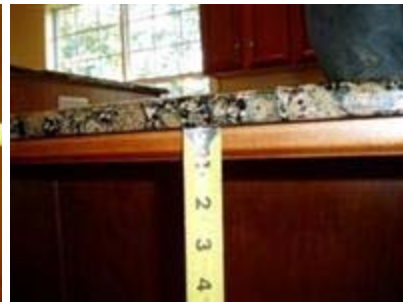
**8.4** Granite countertop should be caulked at the seam of the undermount sink to eliminate a concealed fouling area. Granite countertop on the oven side of the island spans 5' by 2' and is being supported by a vertically oriented 3/4" by 6" section of trim molding; additional reinforcement is highly recommended to prevent the granite from breaking. Recommend further evaluation and repair as needed by a qualified licensed general contractor.

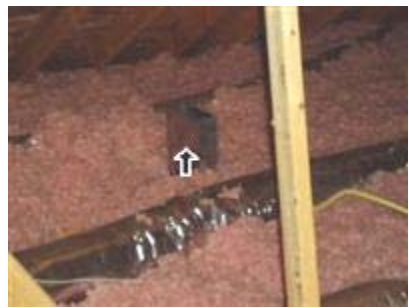
10.2 Picture 1

**10.2** Range hood fan vents into attic space and should vent to the outside. This would require a vent hood and kit. Recommend further evaluation and repair as needed by a qualified licensed general contractor.
