Manufactured-Stone Nightmares

Without proper flashing, heavy-duty building paper, and weep holes, walls behind cast-stone veneer can get wet

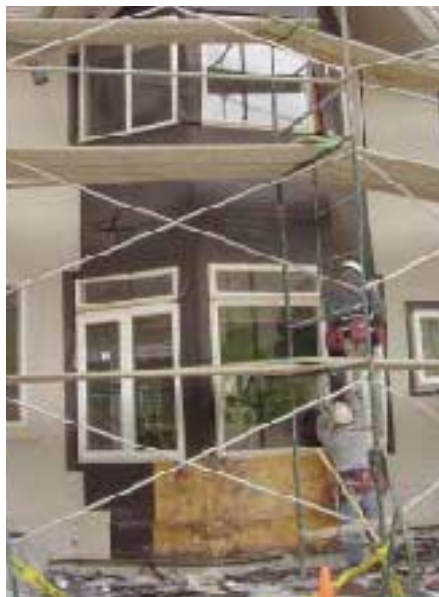
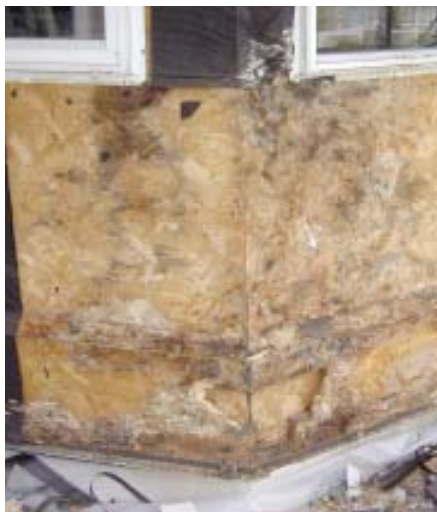
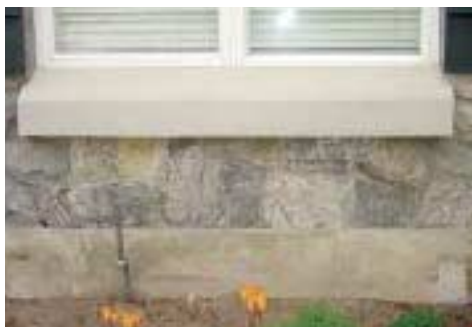
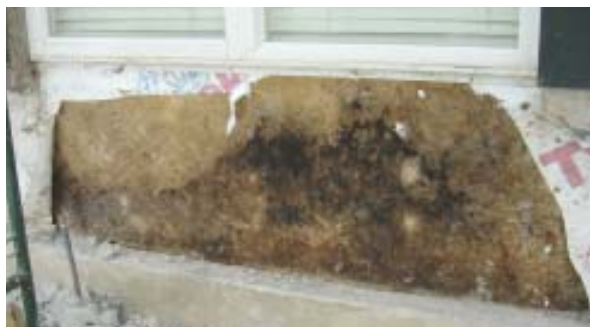
Figure 1. Where stucco (top photos) and cast stone (bottom) have been installed on the same home, the author frequently finds more severe moisture and rot damage under the cast-stone portions of the exterior. One reason is that the stucco terminates at the bottom with a weep screed, while the cast stone sits in a bed of mortar and grout, directly on a foundation ledge, with no weeps or flashings.

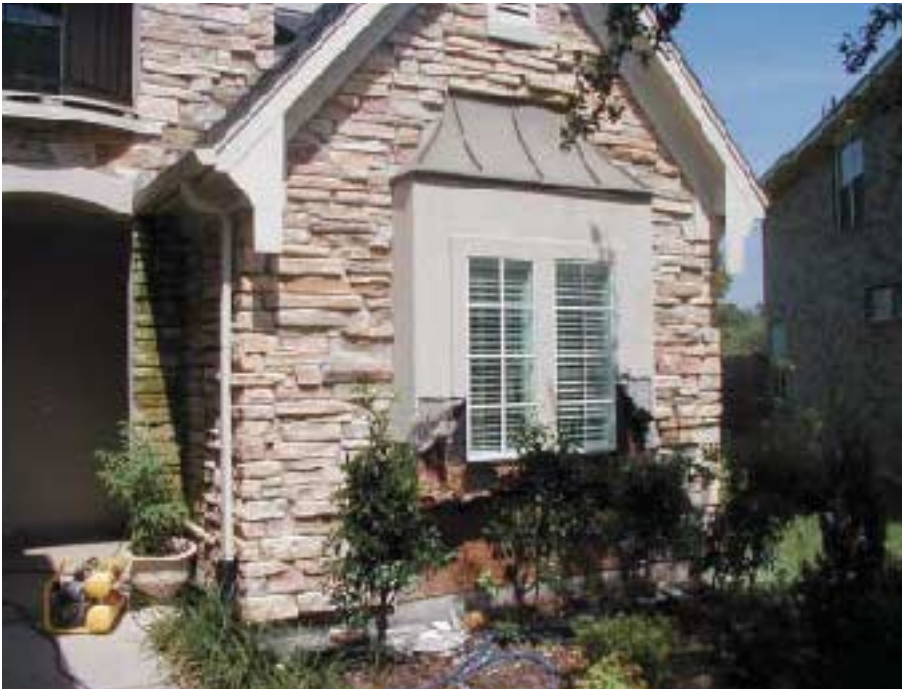
For one thing, manufactured stone is a cement-based product that absorbs and holds water like stucco, but cast stone is thicker than stucco and can thus store more moisture. Also, most of the cast-stone brands now have "ledge-stone" versions of the product, which have a long, horizontal shape; the long, flat, shelflike ledges are often sloped toward the framing when installed, which provides a place for rain water

to puddle up and soak into the wall (Figure 2, next page).

Figure 2. Long, flat “ledgestone” pieces like this create many horizontal shelves where water can stand and soak into grout joints.

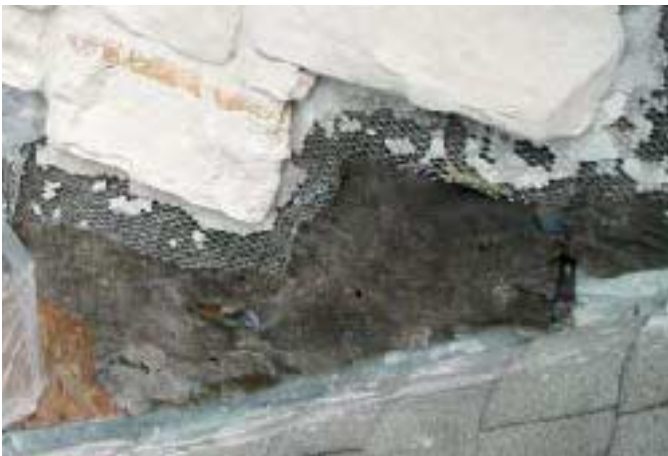
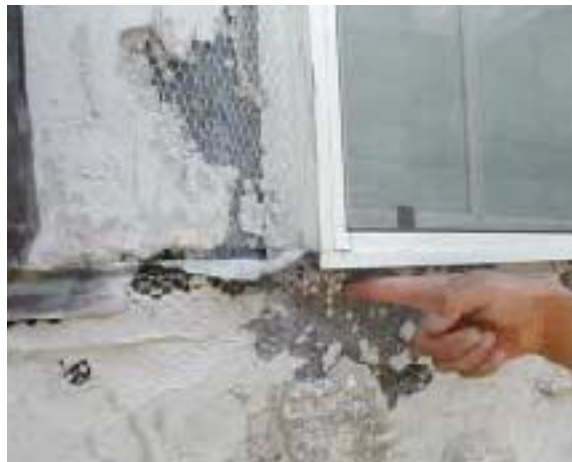
The greater thickness of cast stone also complicates the task of fabricating and installing practical flashing components. The kickout or diverter flashing required where a roofline butts into a wall is a good example. On job after job, my company gets paid good money to go in after the fact, tear cast-stone veneer off a wall, and retrofit a larger kickout flashing to the wall because the original roofer's kickout flashing was too small to push water out beyond the plane of the cladding. If the diverter flashing is too small, it may as well not be there: All the water flowing and blowing against that spot will just get dumped into the wall system below (Figure 3, next page).

Figure 3. Undersized or omitted diverter — or kickout — flashings allow water to flow beneath the cast-stone facade (above). Window flanges that lap under instead of over building paper can bring rain water into direct contact with the sheathing (right).

idea in a manufactured-stone job. However, we are more likely to see a reverse-lap flashing error, with building paper run to the window edge in such a way that the window flange directs water beneath the paper instead of on top of it (Figure 3). And, as with stucco, brick, or any other cladding, a cast-stone veneer should be equipped with weeps of some kind at any bottom termination, whether at the foundation sill or above a window or abutting roof. Otherwise, water will pool longest at the lowest points, and those areas may stay continuously wet.

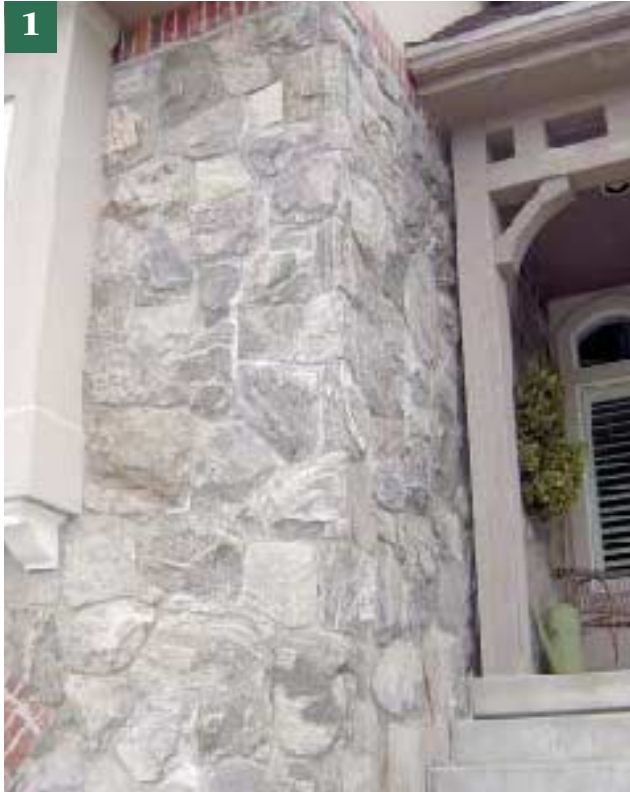
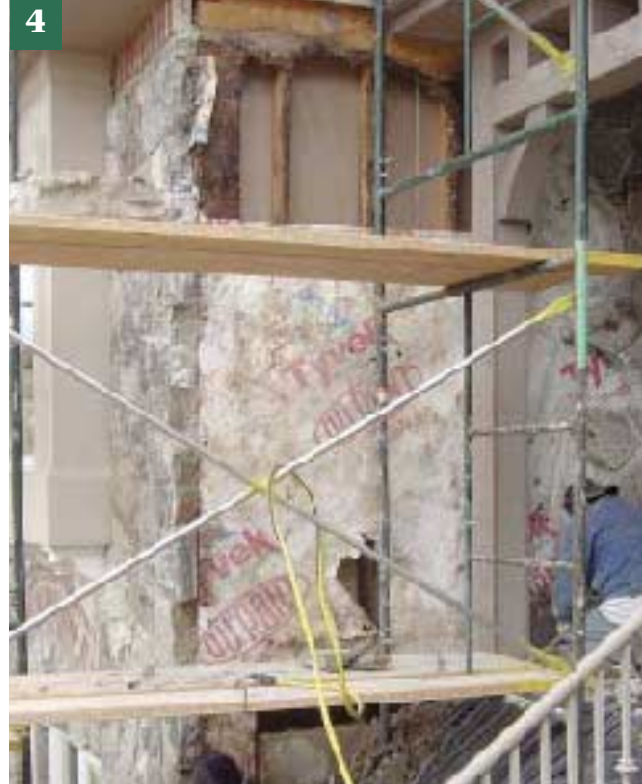
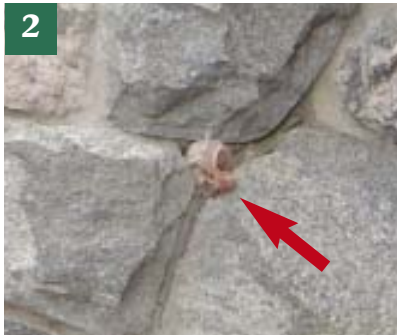
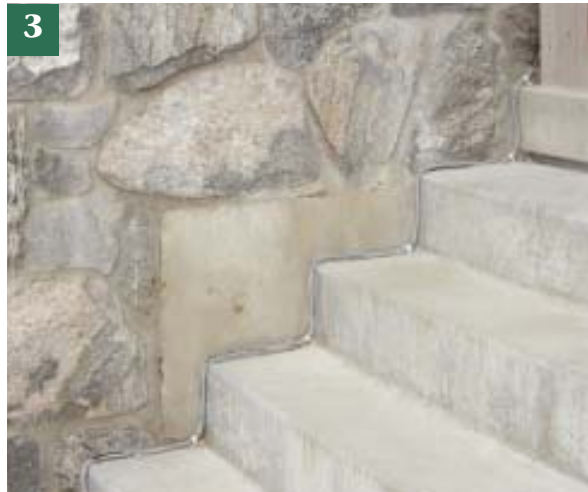
The owners of this one-year-old custom home **1** reported moldy smells behind the drywall; a mushroom growing from the cast-stone veneer face was the only visible sign of trouble on the exterior **2**. The gutter butting into the top of the wall seemed a likely source of moisture, while the bottom of the wall provided no way for moisture to escape **3**.

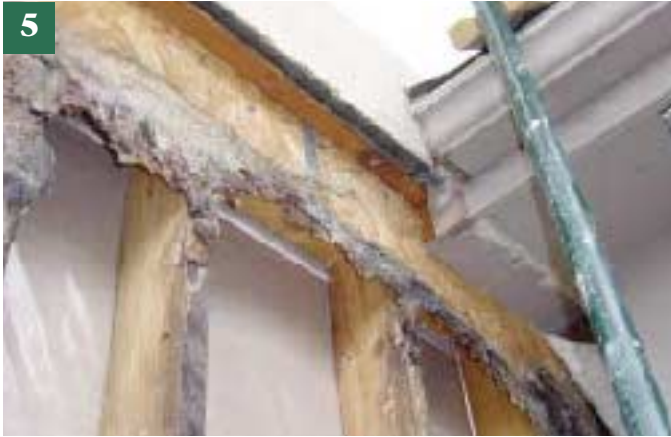
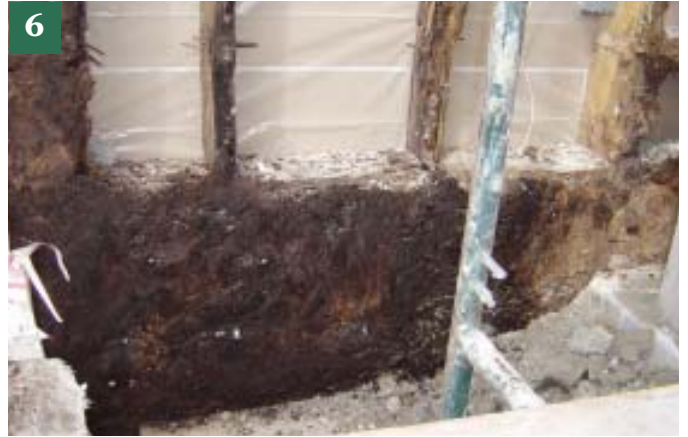
Opening the wall [4](#) revealed severely rotted OSB sheathing and damage to the framing. While the row of soldier bricks at fascia height provided some protection [5](#), the water coming off the roof saturated the cast stone and soaked through the housewrap beneath, turning the sheathing at the base of the wall to compost in less than two years [6](#).

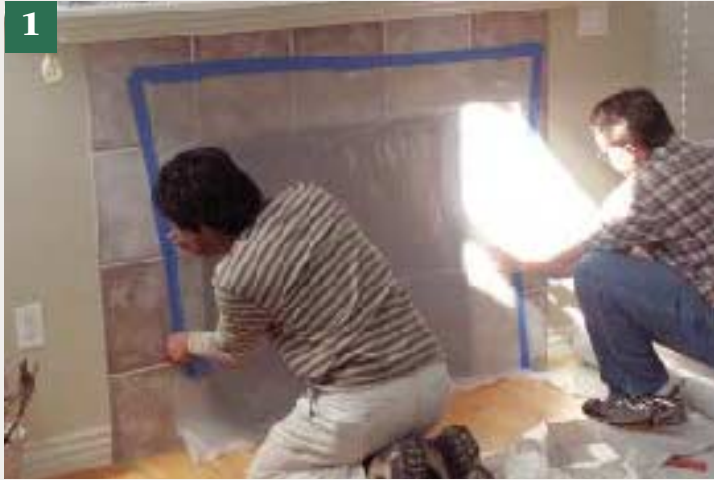
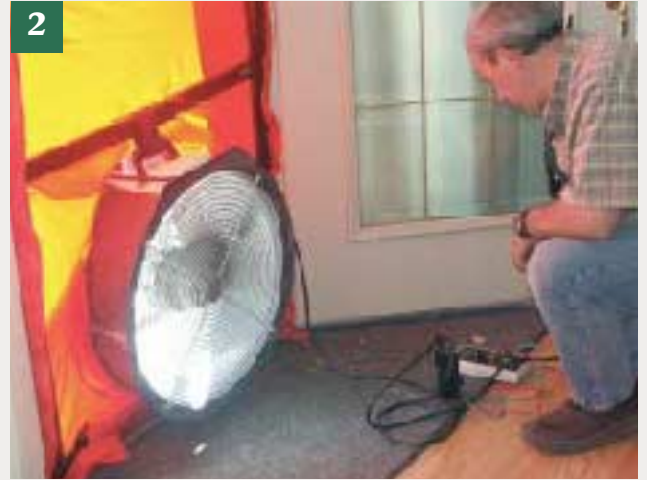
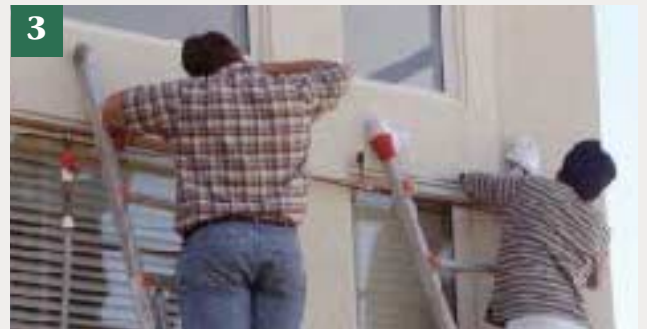
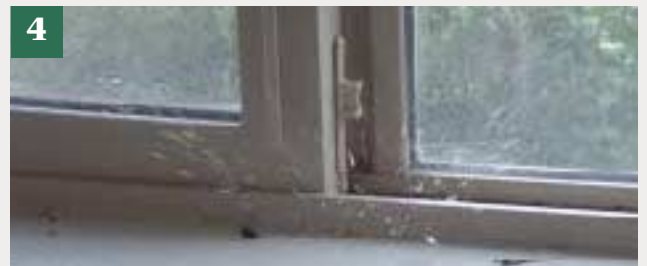
On this job, the original installer of the cast-stone veneer wall had tried unsuccessfully to stop leaks by spraying a clear sealer onto the stone and by removing the lowest courses to apply a membrane flashing where the wall meets the foundation. To assess the problem, the Ram Builders team first seals large openings inside the home **1** and sets up a blower door **2**. With the blower door running to depressurize the house, the crew turns on a water-spray apparatus **3**, thus simulating the effect of a 15-mph wind-driven rain. Within a short time, water finds its way into the house **4**.

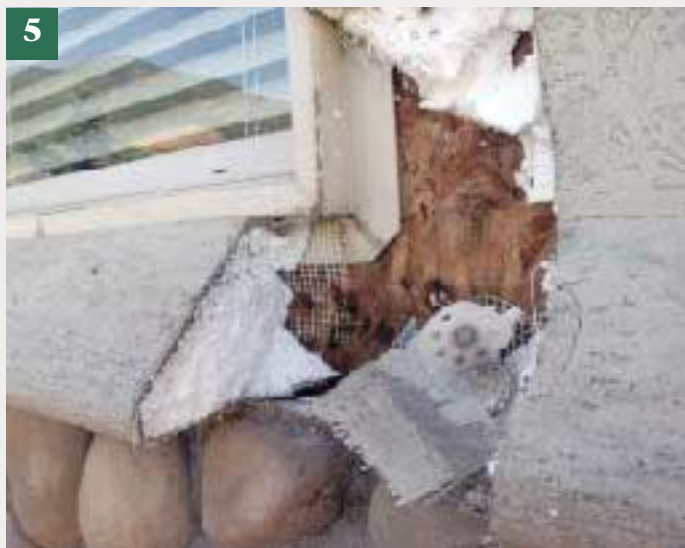
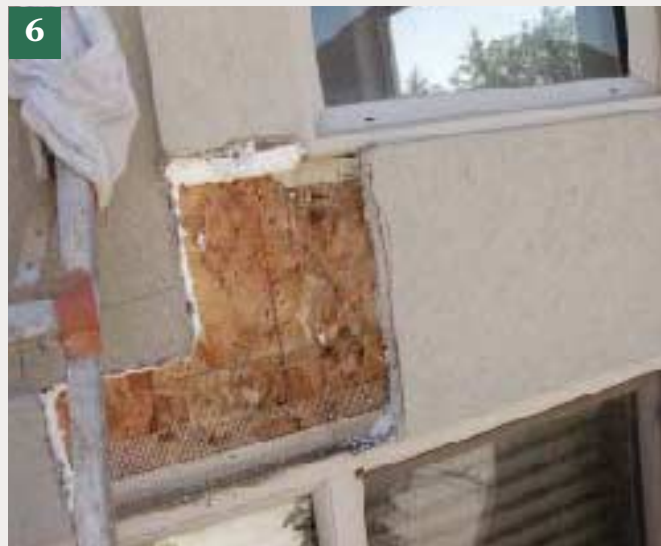
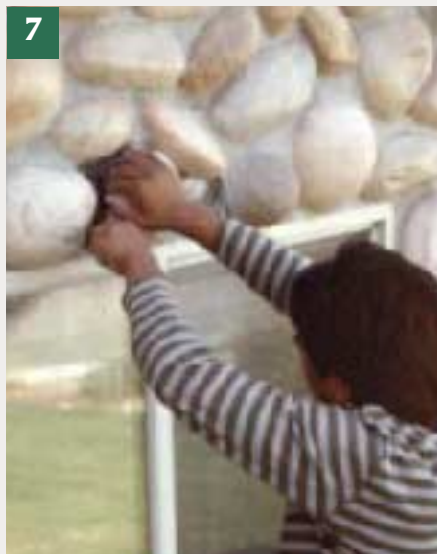
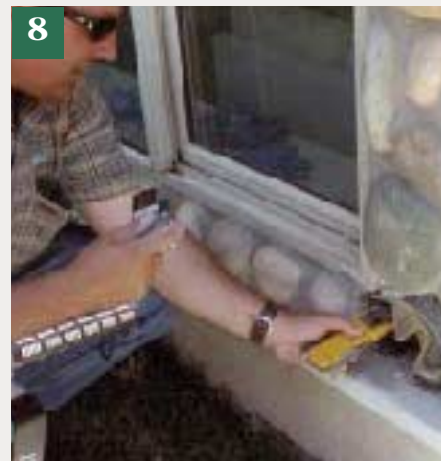
After verifying that the cladding leaks, the team digs under the surface to find out why. Tearing off small areas of EIFS on the upper wall reveals that there is no building paper or window flashing installed where the EIFS meet the cast stone **5**, or between upper and lower windows in the EIFS wall **6**. Tearing off cast stone near a window **7**, the team learns that water has wet the OSB sheathing. The author measures high moisture content even at the bottom of the wall, where no direct stream was applied **8**. The retrofit flashing repair has proven ineffective because flaws higher in the wall dump water behind it.
