Rescuing a Manufactured-Stone Wall

A properly flashed water-resistant drainage plane is essential when installing stone veneer over a wood-framed wall

by Mark Parlee

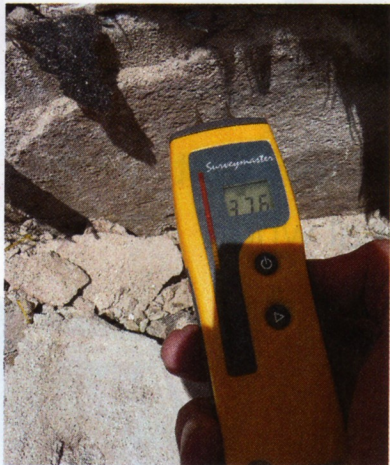
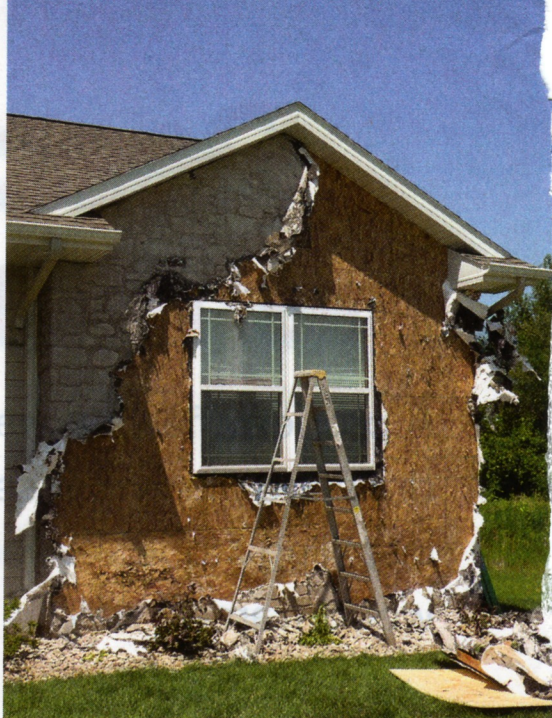
After most of the stone veneer and mortar base coat had been removed and the OSB sheathing exposed, moisture readings confirmed my suspicions: Water was getting behind the cladding and migrating into the wall system — not just around the double window, but everywhere (see Figure 1).

Although the problem was clearly worst around the window, there were elevated moisture levels at the corners of the facade and above the window, as well as in the stone veneer remaining on the wall. Below the window and at the base of the wall, moisture content readings in the wall sheathing exceeded 90 percent.

Figure 1. Though it looked sound from the outside, the manufactured-stone veneer on this nine-month-old house was absorbing water and soaking the mortar base coat (left) and the sheathing and framing underneath. The only way to fix the problem was to pull off the stone (right) and install a proper substrate.
