Inspection Report

Under Construction Phase Inspection

Sample Under Construction
Pre Insulation & Drywall
Fort Mill, SC

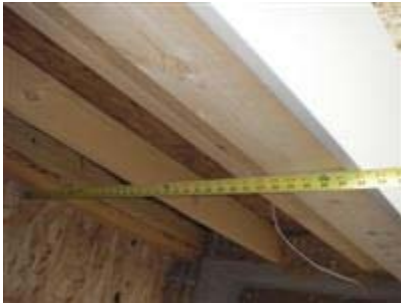
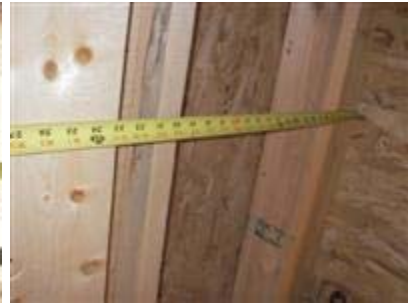
(2) The narrow walls on the left side of the home, as currently installed, around the garage doors will not provide the lateral stability necessary to structurally support the area. Recommend further evaluation and repair as needed by a qualified licensed professional engineer. Refer to the attached Narrow Bracing Options publication from the Engineered Wood Association for supporting information and documentation.

1.1 Picture 12 38" wide

1.1 Picture 14 28" Wide

- (2) The narrow walls on the left side of the home, as currently installed, around the garage doors will not provide the lateral stability necessary to structurally support the area. Recommend further evaluation and repair as needed by a qualified licensed professional engineer. Refer to the attached Narrow Bracing Options publication from the Engineered Wood Association for supporting information and documentation.

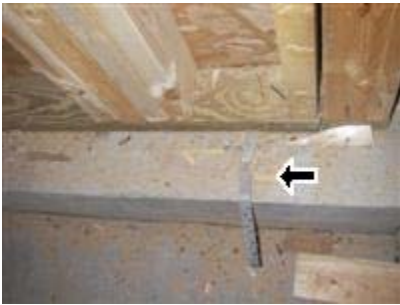
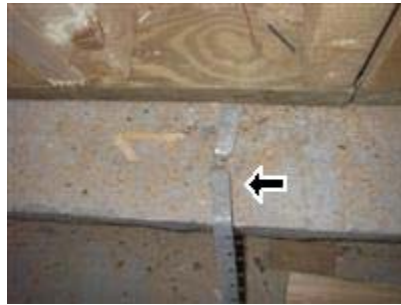
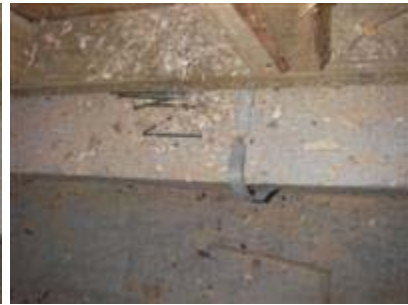
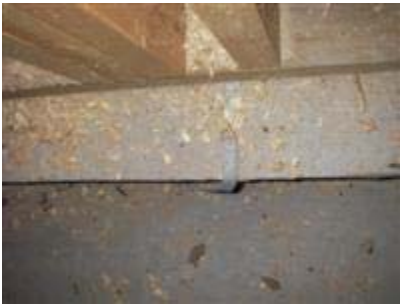
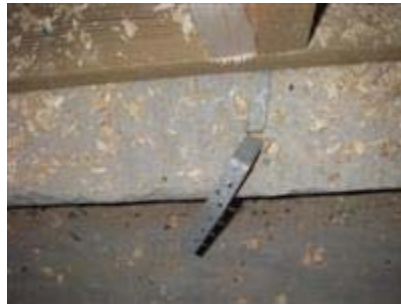
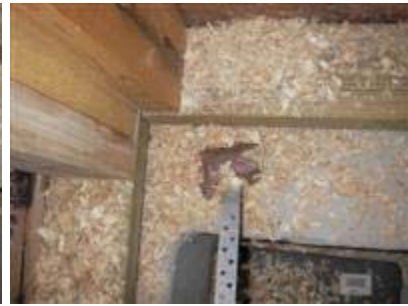
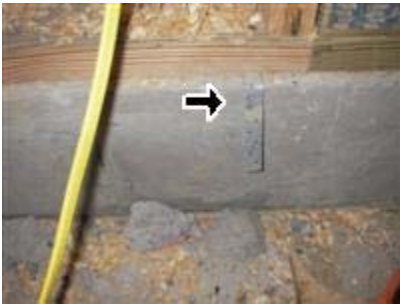
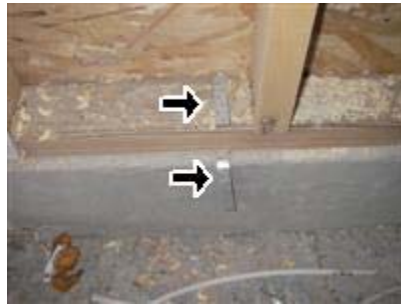
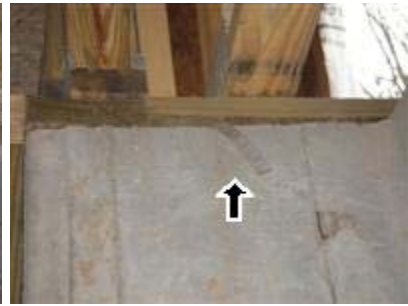
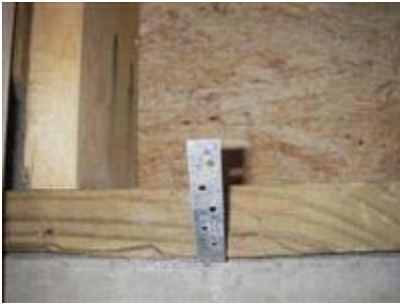
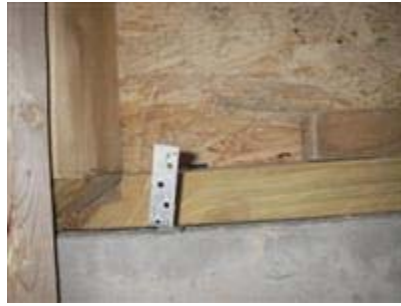
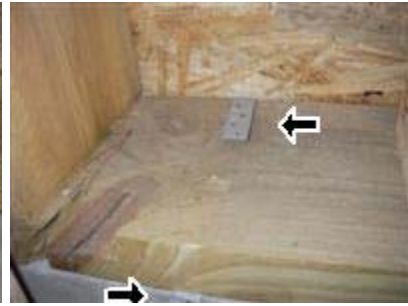
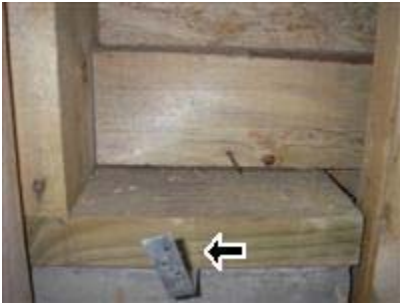
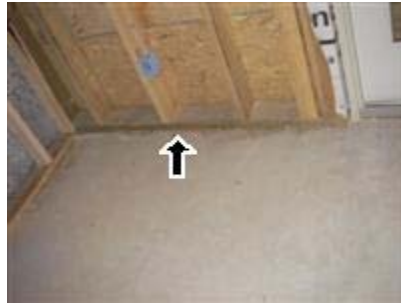
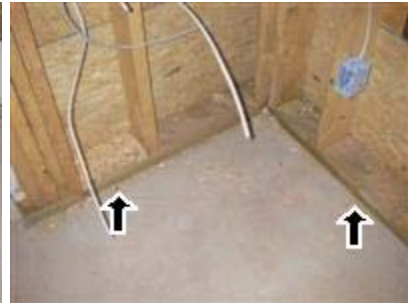
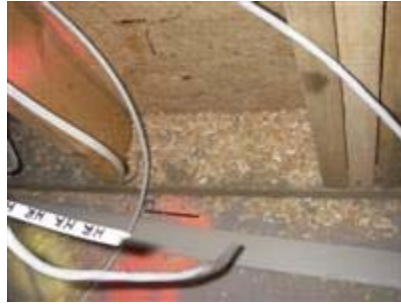
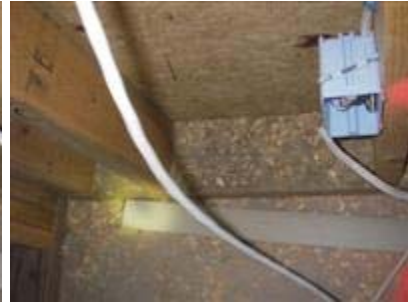
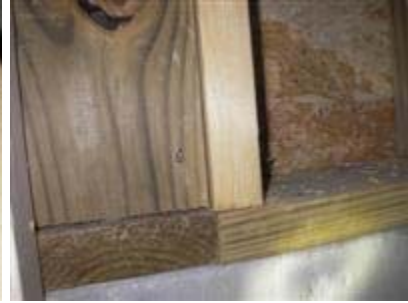
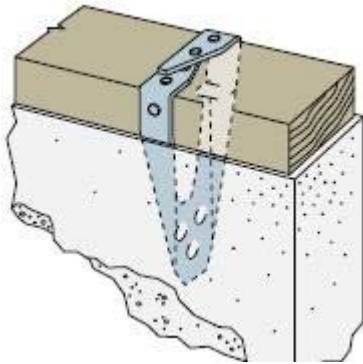
(3) Mud sill straps are not properly installed along the front wall of the garage, rear wall of the garage, and all walls in the basement. In some cases the straps can not be installed according to the manufacturers instructions, anchor bolting may be required. If not corrected the home will not be properly secured to the foundation. Recommend further evaluation and repair as needed by a qualified licensed general contractor.

- (3) Mud sill straps are not properly installed along the front wall of the garage, rear wall of the garage, and all walls in the basement. In some cases the straps can not be installed according to the manufacturers instructions, anchor bolting may be required. If not corrected the home will not be properly secured to the foundation. Recommend further evaluation and repair as needed by a qualified licensed general contractor.

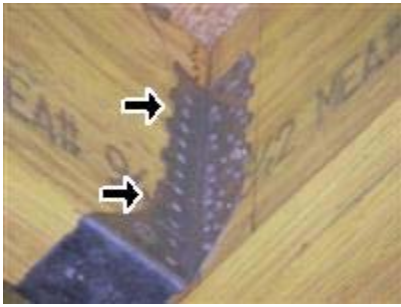
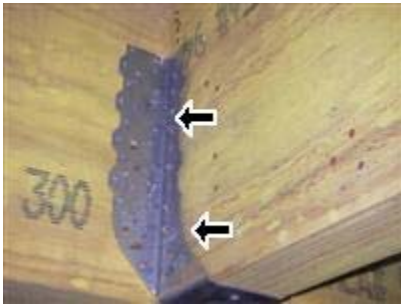
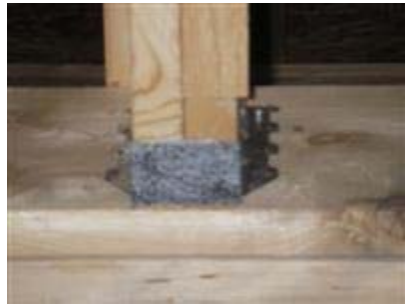
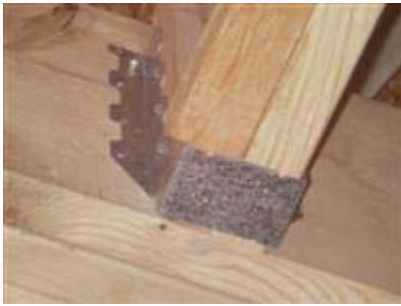
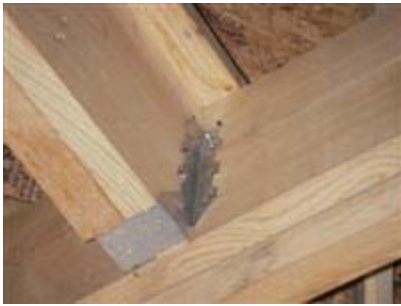
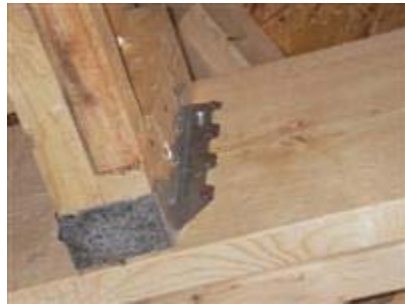
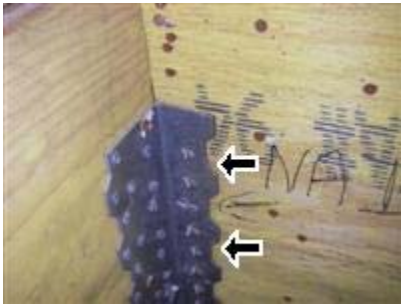
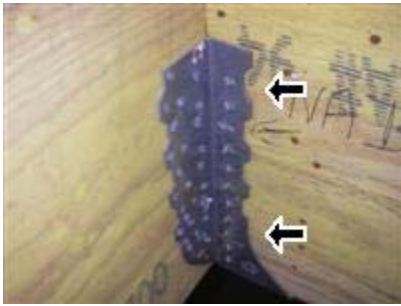
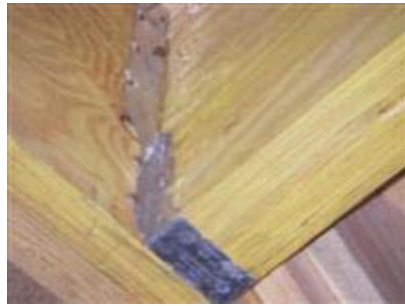
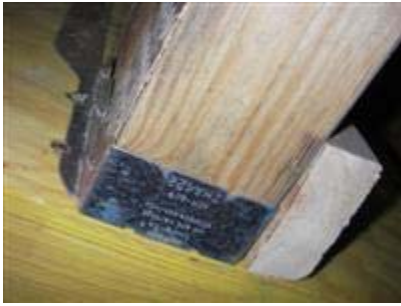
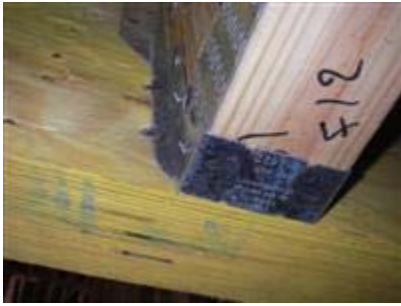
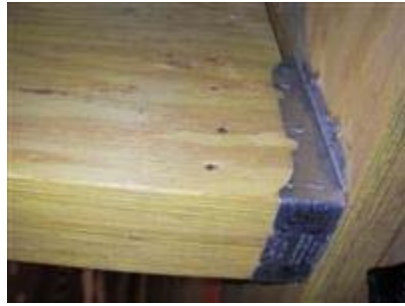
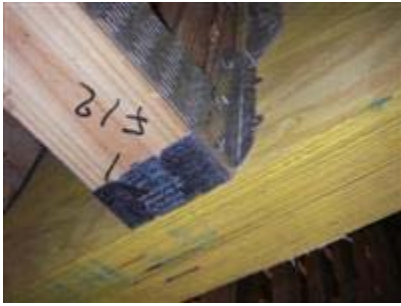
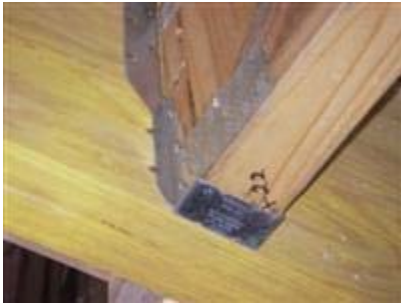
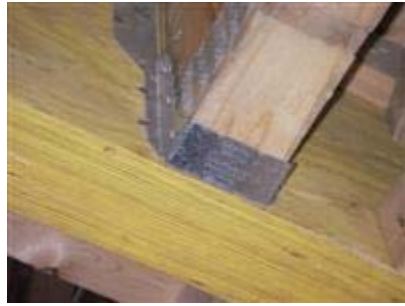
(4) The majority of the installed joist hangers throughout the home are missing nails in all of the round nail holes/manufactured required nailing holes. Recommend further evaluation and repair as needed by a qualified licensed general contractor.

- (4) The majority of the installed joist hangers throughout the home are missing nails in all of the round nail holes/manufactured required nailing holes. Recommend further evaluation and repair as needed by a qualified

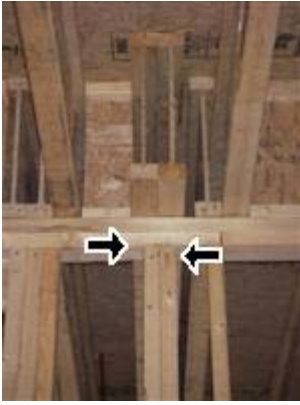
1.1 Picture 56

(5) The double I joist that runs left to right over the garage is being braced by 2 studs along the dining room wall. Many construction professionals would consider this substandard and add additional studs for support. Recommend further evaluation and repair as needed by a qualified licensed general contractor.

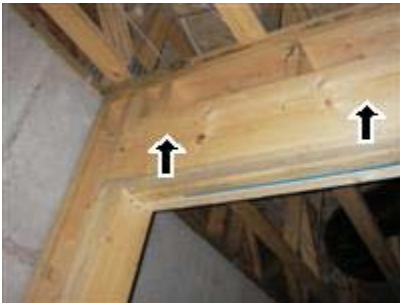
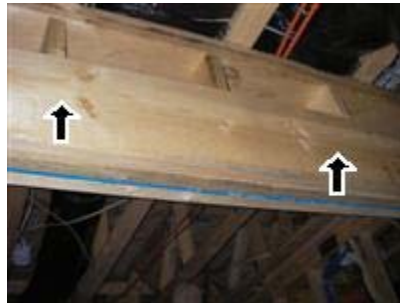
(6) One of the header boards above the entrance way to the basement furnace/utility room has a horizontal crack that runs across the board. Recommend further evaluation and repair as needed by a qualified licensed general contractor.

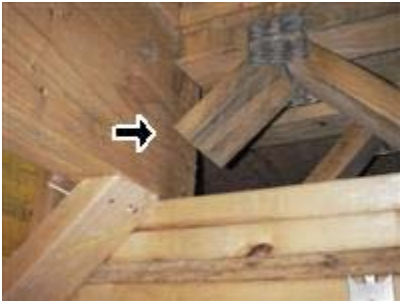
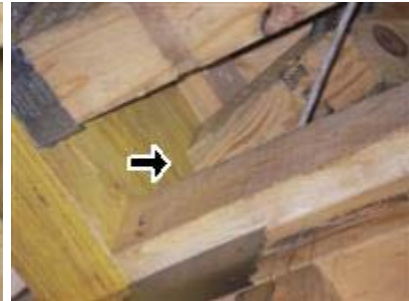
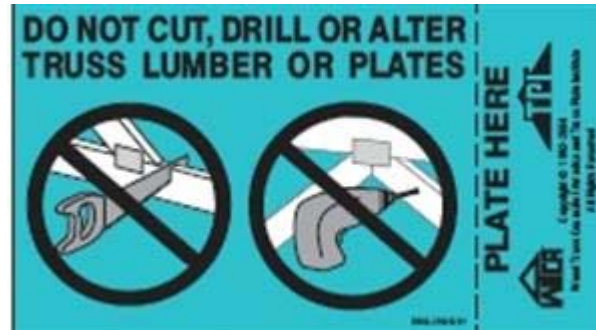
1.3 (1) The engineered floor truss that is installed beside the basement staircase has been cut/modified by a tradesman. The top chord of the engineered cripple wall under the laundry room area has been damaged by tradesman. No repair attempts were evident. Any modifications to an engineered product need to be designed and approved by a technical representative from the product manufacturer or a professional engineer. Recommend further evaluation and repair as needed by a qualified technical representative from the manufacturer or a professional engineer. You should obtain the stamped repair document that the professional designed and approved.

(1) The engineered floor truss that is installed beside the basement staircase has been cut/modified by a tradesman. The top chord of the engineered cripple wall under the laundry room area has been damaged by tradesman. No repair attempts were evident. Any modifications to an engineered product need to be designed and approved by a technical representative from the product manufacturer or a professional engineer. Recommend further evaluation and repair as needed by a qualified technical representative from the manufacturer or a professional engineer. You should obtain the stamped repair document that the professional designed and approved.

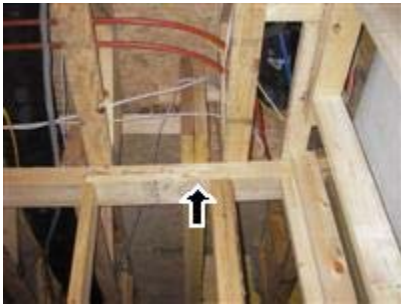
1.3 Picture 6

(2) Inspected a two ply LVL that runs along one side of the basement staircase that is not braced directly on the underside nearest the left side of the home. Recommend further evaluation and repair as needed by a qualified licensed general contractor.

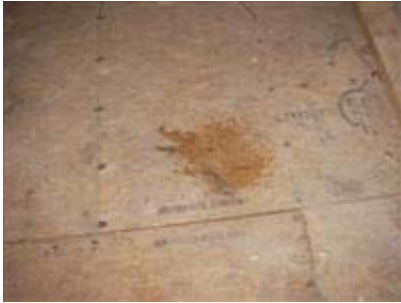
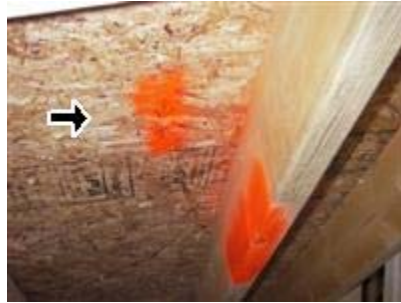
1.5 (1) Located a small roof leak at a nail along in the storage area over the garage. Repairs are advised. Recommend further evaluation and repair as needed by a qualified licensed general contractor.

(1) Located a small roof leak at a nail along in the storage area over the garage. Repairs are advised. Recommend further evaluation and repair as needed by a qualified licensed general contractor.

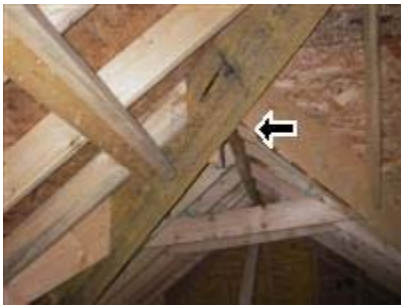
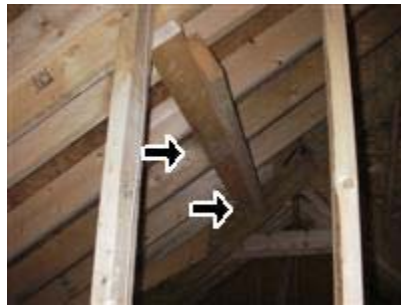
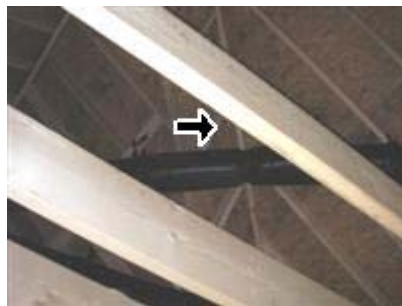
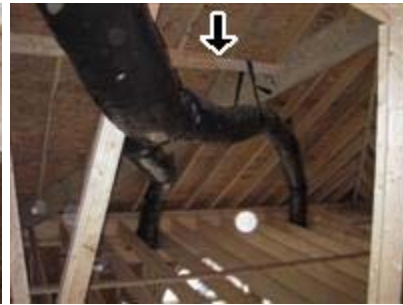
(2) Vertical bracing is not installed at some of the ridge beam and hip rafter/valley rafter intersections. Some of the installed purlins are not braced and or brace are spaced in excess of 4' apart. Mid beam vertical bracing is not installed at all of the valley and hip rafters. Most of the vertical bracing that was currently installed was less than 1/2 of the dimension of the beam they were supporting. Many construction professionals would consider this substandard. Recommend further evaluation and repair as needed by a qualified licensed general contractor.

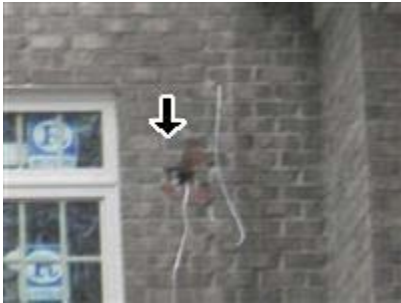
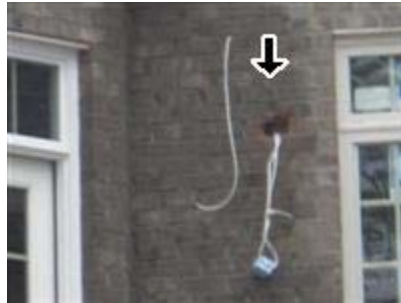
2.0 (1) Brick veneer was damaged around the electrical receptacles on the rear of the home. Recommend further evaluation and repair as needed by a

qualified licensed general contractor.

(1) Brick veneer was damaged around the electrical receptacles on the rear of the home. Recommend further evaluation and repair as needed by a qualified licensed general contractor.

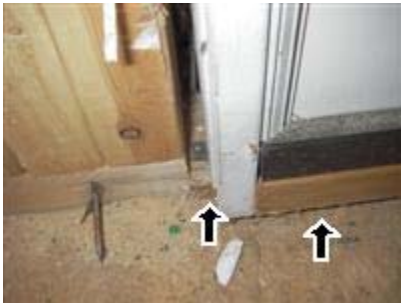
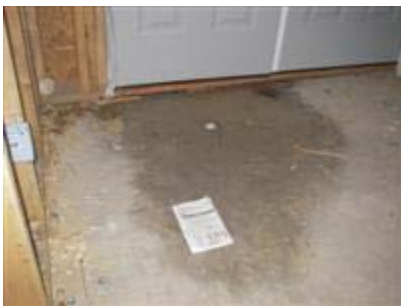
(2) No flashing has been installed under all of the exterior doors. Water intrusion was present under some of the doors. Water intrusion and deterioration can occur at doors that are not properly flashed. Recommend further evaluation and repair as needed by a qualified licensed general contractor.

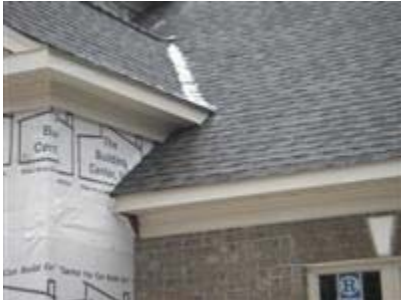
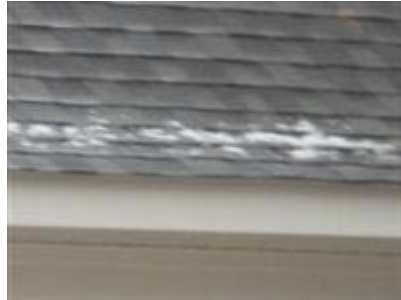
3.0 Shingles mostly above the eaves around the home are damaged from what most likely was toe boards being nailed to the roof. Leaks can develop if not properly repaired. Recommend further evaluation and repair as needed by a qualified licensed general contractor.

Shingles mostly above the eaves around the home are damaged from what most likely was toe boards being nailed to the roof. Leaks can develop if not properly repaired. Recommend further evaluation and repair as needed by a qualified licensed general contractor.

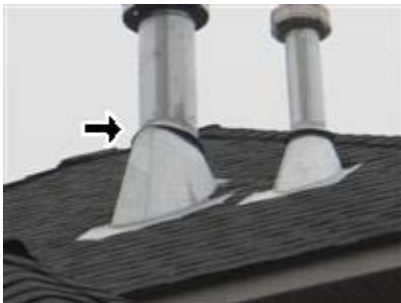
3.2 Picture 1

3.2 Ring is installed crooked at the furnace flue pipe/flange connection. Leaks can develop if this is not properly installed. Recommend further evaluation and repair as needed by a qualified licensed general contractor.

Ring is installed crooked at the furnace flue pipe/flange connection. Leaks can develop if this is not properly installed. Recommend further evaluation and repair as needed by a qualified licensed general contractor.

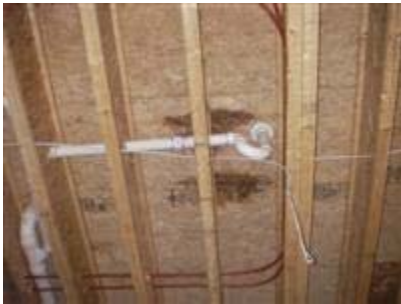
4.0 Picture 1

4.0 (1) Evidence suggests there is/was a leak around the bathroom drain line above the garage. Repairs are advised. Recommend further evaluation and repair as needed by a qualified licensed plumbing contractor.

(1) Evidence suggests there is/was a leak around the bathroom drain line above the garage. Repairs are advised. Recommend further evaluation and repair as needed by a qualified licensed plumbing contractor.

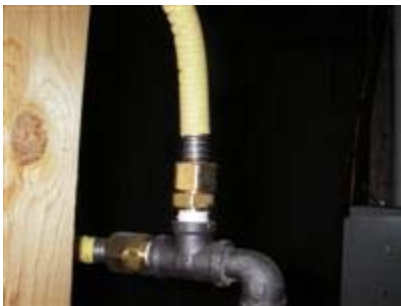
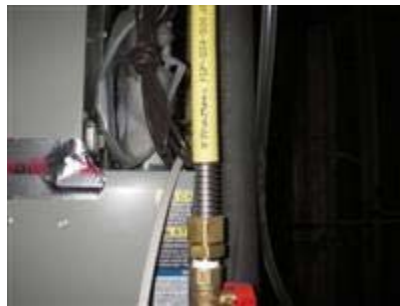
The gas line piping in the subject property is Corrugated Stainless Steel Tubing or referred to simply as "CSST." A nationwide class action has been filed on behalf of any and all persons and/or entities who own structures in the United States in which CSST manufactured by Titeflex, Ward, OmegaFlex or Parker Hannifin was installed as of September 5, 2006. Plaintiffs allege that CSST poses an unreasonable risk of fire due to lightning strikes if the piping is not bonded, the piping was not bonded at the time of the inspection. Further information on the suit is available at www.csstsettlement.com Recommend further evaluation and repair as needed by a qualified licensed electrical contractor. The publication "Lightning Safety for Gas Piping" by TracPipe is attached to the end of the report for supporting documentation.

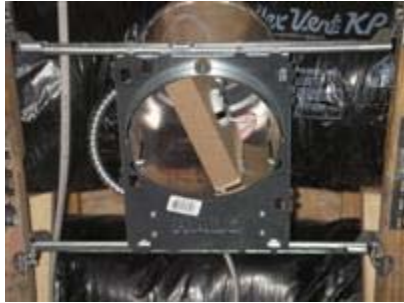
5.3 Picture 1

5.3 (1) Recessed lights that were installed in the basement were in contact with the HVAC duct work. The lights are not approved for insulation contact or to be placed within 3" of insulation. Moving either the duct work or lights or replacing the lights with insulation contact approved fixtures is advised for fire safety reasons. Recommend further evaluation and repair as needed by a qualified licensed general contractor.

(1) Recessed lights that were installed in the basement were in contact with the HVAC duct work. The lights are not approved for insulation contact or to be placed within 3" of insulation. Moving either the duct work or lights or replacing the lights with insulation contact approved fixtures is advised for fire safety reasons. Recommend further evaluation and repair as needed by a qualified licensed general contractor.

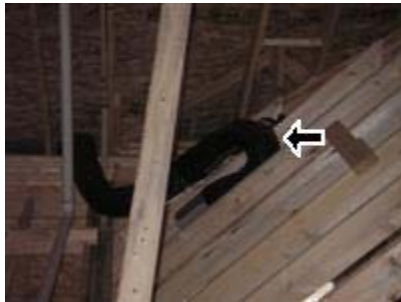
9.2 Picture 1

9.2 (1) Vent piping for the master bath fan is kinked, air flow may be restricted. Recommend further evaluation and repair as needed by a qualified licensed general contractor.

(1) Vent piping for the master bath fan is kinked, air flow may be restricted. Recommend further evaluation and repair as needed by a qualified licensed general contractor.
