# Inspection Report

## Custom Built New Home Listed at over \$500,000

**Property Address:**  
123 New Home Way  
Any City, SC

**King Construction, Inc dba Inspector Paul**

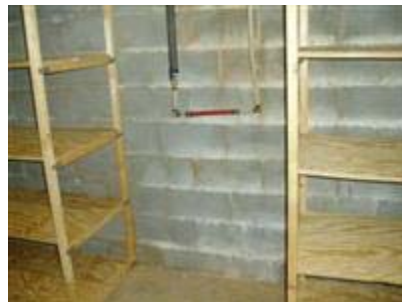
1.0 Picture 3

(2) A long crack was inspected in the basement slab, starting at the left side wall near the water main and heading towards the basement bathroom area. A crack was inspected in the front left corner of the basement, under the entrance foyer area. Cracks were located in the basement slab around the wood support posts for the LVL girders, we could not determine if the slab was properly poured to support the additional load under the vertical posts. Evidence suggests that these conditions are also present in the inaccessible / finished areas of the basement but that can no be confirmed with out being destructive. A structural engineer should be retained to determine if the condition exists at all foundation areas where columns are installed and repairs should be made per their recommendations.

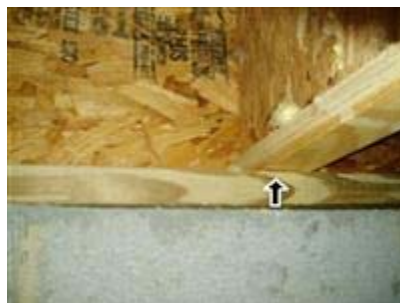
I.1 Picture 3

**1.1** All visible areas of floors are missing blocking panels, web stiffeners, and squash blocks that should be installed in accordance with manufacturers instructions. Several engineered I joists have wood wedge shims installed between the mudsill and bottom of the joist. The rim band on the front of the home and rear of the home are engineered I joists, these may not be structurally sound to support the loads above. Repairs are advised for structural integrity. The floor joists manufacturer instructions are attached to the end of this report for clarification. Evidence suggests that these conditions are also present in the inaccessible / finished areas of the basement but that can no be confirmed with out being destructive. A structural engineer should be retained to determine if the condition exists at all floor areas and repairs should be made per their recommendations.

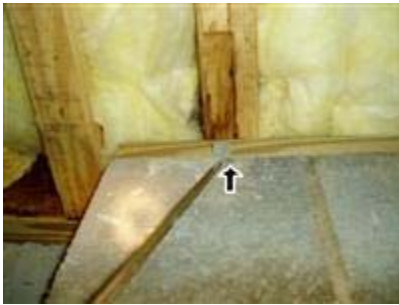
1.2 Picture 10

1.2 (1) The mudsill should be secured to the block foundation wall with proper anchor bolts or mudsill anchors per manufacturers instructions. We could not locate a single anchor bolt and every mudsill anchor we could locate did not have a single nail securing the mudsill to the block wall. Manufacturers installation instructions are attached to the report. Evidence suggests that this condition is also present in the inaccessible/finished areas of the basement but that can no be confirmed with out being destructive. A structural engineer should be retained to determine if the condition exists at all walls and repairs should be made per their recommendations.
