Manufactured-Stone Nightmares

Without proper flashing, heavy-duty building paper, and weep holes, walls behind cast-stone veneer can get wet

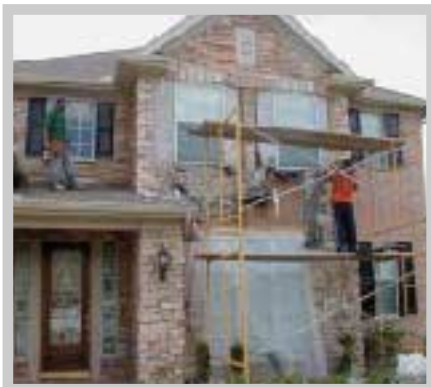
leaks and rot often show up sooner, progress more quickly, and cause more severe damage inside the wall (see Figure 1).

Figure 1. Where stucco (top photos) and cast stone (bottom) have been installed on the same home, the author frequently finds more severe moisture and rot damage under the cast-stone portions of the exterior. One reason is that the stucco terminates at the bottom with a weep screed, while the cast stone sits in a bed of mortar and grout, directly on a foundation ledge, with no weeps or flashings.
