Rescuing a Manufactured-Stone Wall

A properly flashed water-resistant drainage plane is essential when installing stone veneer over a wood-framed wall

by Mark Parlee

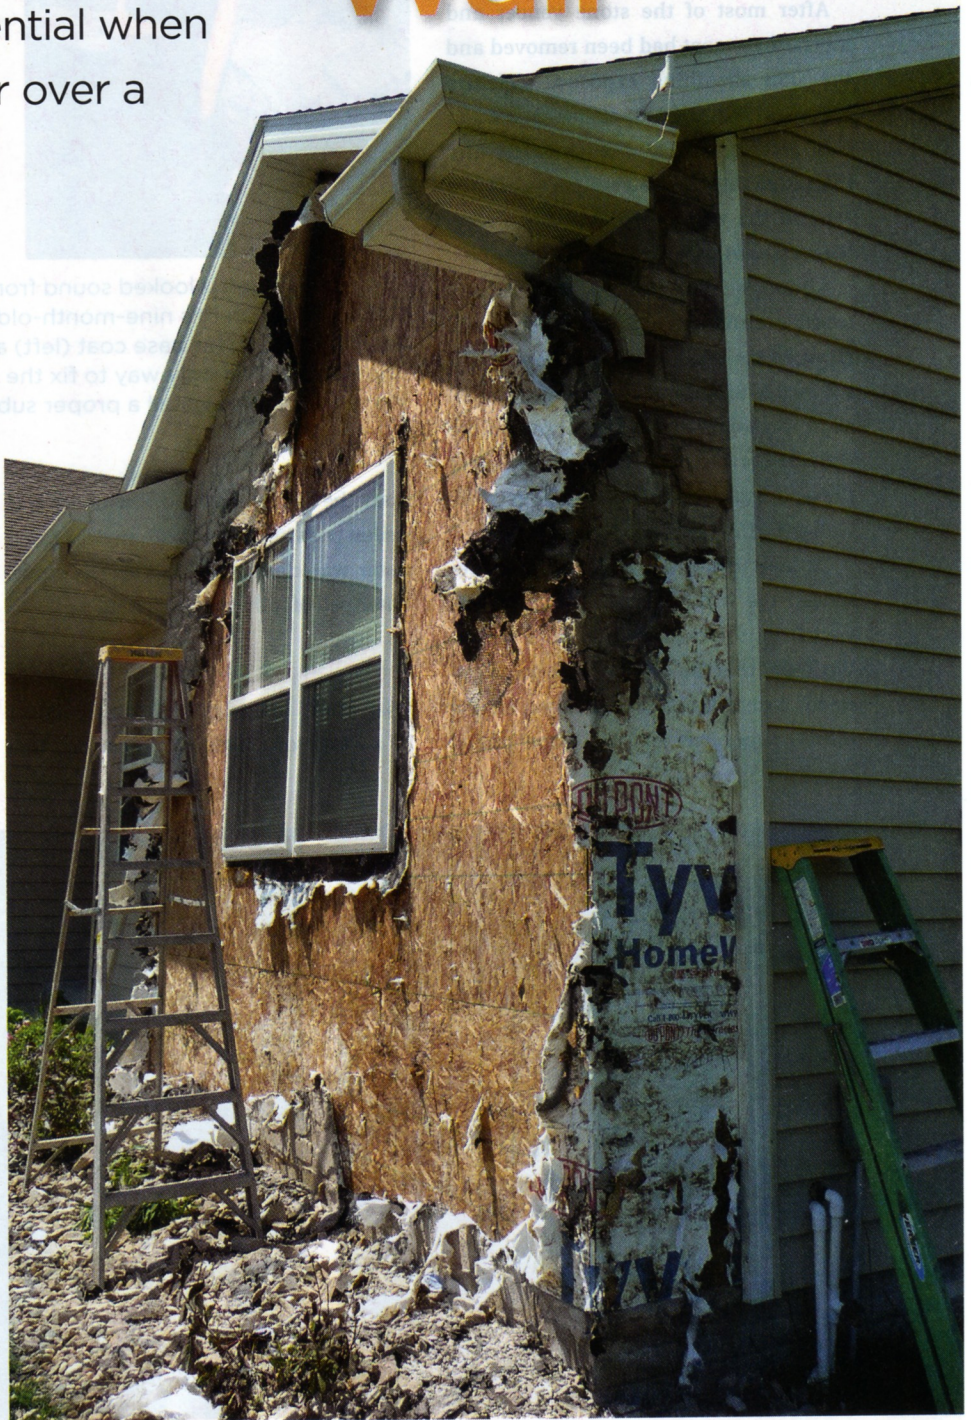
On the exterior, the manufactured-stone cladding looked undamaged, but I strongly suspected that the problem

wasn't just a leaky window. Because new flashing hadn't helped and there weren't any other obvious explanations for the leaks, my recommendation was to remove the stone cladding and start all over again.

After most of the stone veneer and mortar base coat had been removed and the OSB sheathing exposed, moisture readings confirmed my suspicions: Water was getting behind the cladding and migrating into the wall system — not just around the double window, but everywhere (see Figure 1).

Although the problem was clearly worst around the window, there were elevated moisture levels at the corners of the facade and above the window, as well as in the stone veneer remaining on the wall. Below the window and at the base of the wall, moisture content readings in the wall sheathing exceeded 90 percent.
