Inspection Report

Under Construction Phase Inspection

Sample Under Construction
Pre Insulation & Drywall
Fort Mill, SC

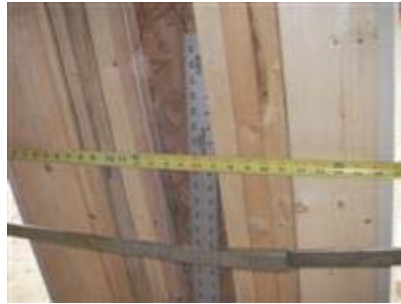
1.1 Picture 13 27" wide

(2) The narrow walls on the left side of the home, as currently installed, around the garage doors will not provide the lateral stability necessary to structurally support the area. Recommend further evaluation and repair as needed by a qualified licensed professional engineer. Refer to the attached Narrow Bracing Options publication from the Engineered Wood Association for supporting information and documentation.

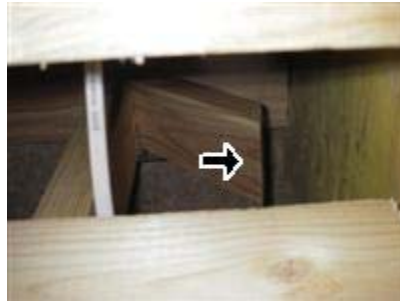
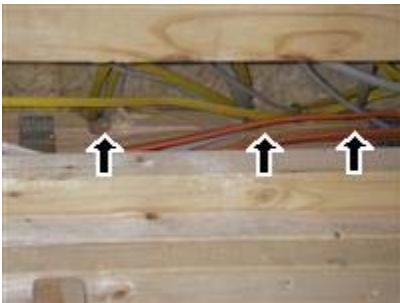
1.3 (1) The engineered floor truss that is installed beside the basement staircase has been cut/modified by a tradesman. The top chord of the engineered cripple wall under the laundry room area has been damaged by tradesman. No repair attempts were evident. Any modifications to an engineered product need to be designed and approved by a technical representative from the product manufacturer or a professional engineer. Recommend further evaluation and repair as needed by a qualified technical representative from the manufacturer or a professional engineer. You should obtain the stamped repair document that the professional designed and approved.

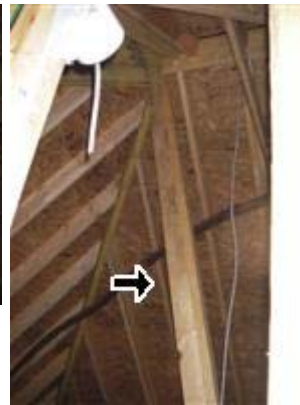
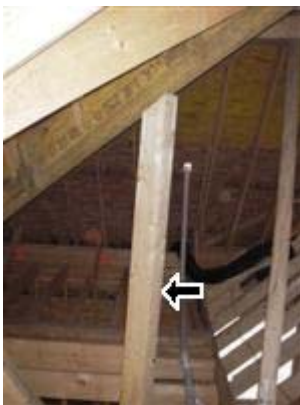
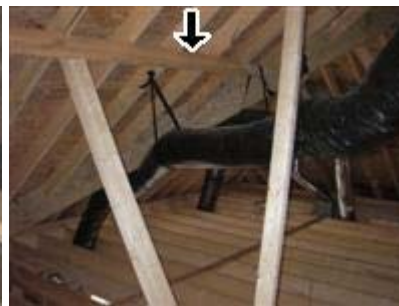
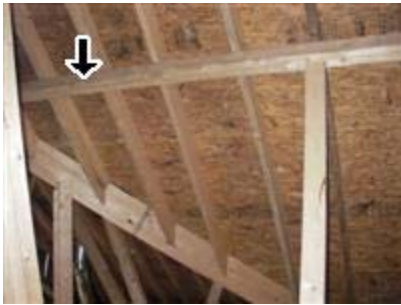
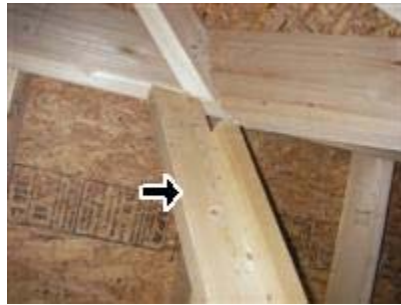
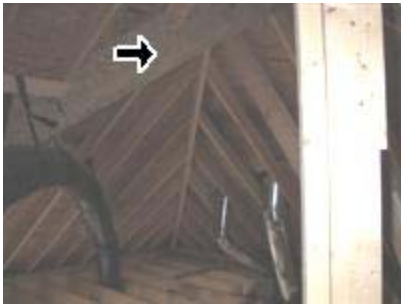
(2) Vertical bracing is not installed at some of the ridge beam and hip rafter/valley rafter intersections. Some of the installed purlins are not braced and or brace are spaced in excess of 4' apart. Mid beam vertical bracing is not installed at all of the valley and hip rafters. Most of the vertical bracing that was currently installed was less than 1/2 of the dimension of the beam they were supporting. Many construction professionals would consider this substandard. Recommend further evaluation and repair as needed by a qualified licensed general contractor.

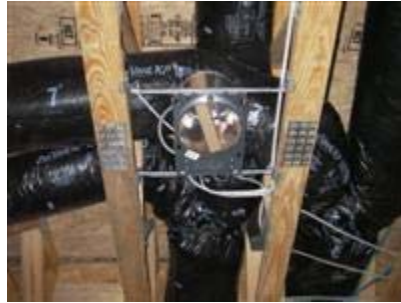
5.3 Picture 2

(2) Could not be fully inspected, not completely installed.

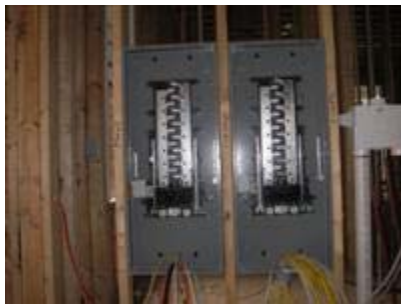
5.6 Picture 1

5.6 Main panel box is located at garage. Could not be fully inspected, not completely installed.
